Utility Conflict Report

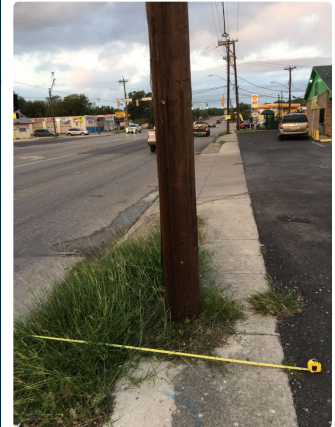
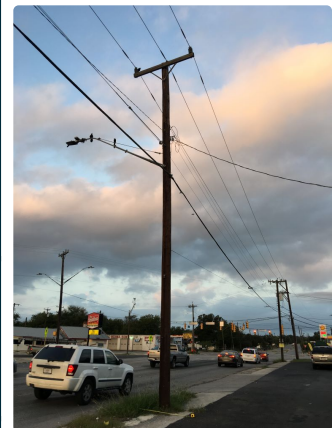
OWNER	Utility	CPS	Corridor	RIGSBY	SITE PHOTOS
	Contact	JAKE MARTINEZ	ID	2074	
GENERAL INFO	Utility	ELECTRIC			
	Size and Material	STANDARD POWER POLE, TIMBER			
	Utility Conflict Description	POLE WITHIN PROPOSED SIDEWALK			
	Longitudinal or Crossing	CROSSING			
	Placement Relative to ROW	INSIDE			
LOCATION	Sheet No.	326			
	Station Origin				
	Start Station	660+55.54	End Station		
	Start Offset	10.3	End Offset		
	Latitude	29.398172853	Longitude	-98.435740253999995	
SUE	Level of Investigation Req'd	NONE			
	Test Hole No	N/A			
	Test Hole Depth	N/A			
RESOLUTION	Recommended Action	ACCOMMODATE - RELOCATION			
	Estimated Resolution Date				
	Resolution Status	UTILITY COORDINATION IN PROGRESS

Comment	INSUFFICIENT CLEARANCE PER PROWAG, 48" CLEARANCE REQUIRED. 39" BACK OF CURB TO FACE OF POLE, 16" POLE DIA, 25" BACK OF POLE TO ROW (BACK OF SIDEWALK)			
Date Collected		8/14/2017 11:29:57 AM	Date Modified		11/9/2017 5:45:01 PM
