## Utility Conflict Report

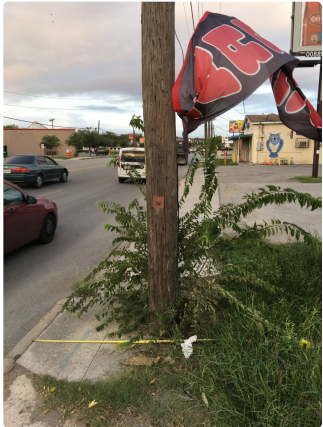
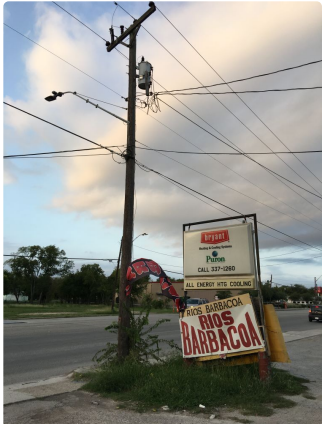
<b>OWNER</b>	<b>Utility</b>	CPS	<b>Corridor</b>	RIGSBY	<b>SITE PHOTOS</b>	
	<b>Contact</b>	JAKE MARTINEZ	<b>ID</b>	228		
<b>GENERAL INFO</b>	<b>Utility</b>	ELECTRIC				
	<b>Size and Material</b>	STANDARD POWER POLE, TIMBER				
	<b>Utility Conflict Description</b>	POLE WITHIN PROPOSED SIDEWALK				
	<b>Longitudinal or Crossing</b>	CROSSING				
	<b>Placement Relative to ROW</b>	INSIDE				
<b>LOCATION</b>	<b>Sheet No.</b>	325				
	<b>Station Origin</b>					
	<b>Start Station</b>	656+41.24	<b>End Station</b>			
	<b>Start Offset</b>	9.4	<b>End Offset</b>			
	<b>Latitude</b>	29.398165289	<b>Longitude</b>	-98.434439327000007		
<b>SUE</b>	<b>Level of Investigation Req'd</b>	NONE				
	<b>Test Hole No</b>	N/A				
	<b>Test Hole Depth</b>	N/A				
<b>RESOLUTION</b>	<b>Recommended Action</b>	ACCOMODATE - RELOCATION				
	<b>Estimated Resolution Date</b>					
	<b>Resolution Status</b>	UTILITY COORDINATION IN PROGRESS				
	<b>Comment</b>	INSUFFICIENT CLEARANCE PER PROWAG, 48" CLEARANCE REQUIRED. 41" BACK OF CURB TO FACE OF POLE, 14" POLE DIA, 19" BACK OF POLE TO ROW (BACK OF SIDEWALK)
