Utility Conflict Report

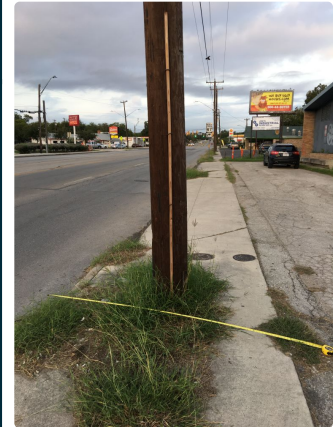
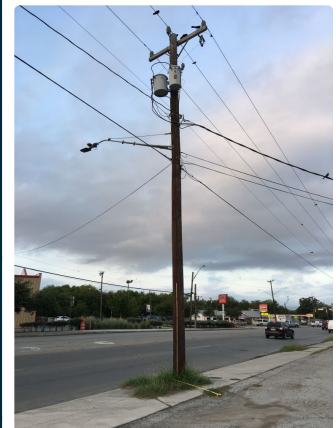
OWNER	Utility	CPS	Corridor	RIGSBY	SITE PHOTOS
	Contact	JAKE MARTINEZ	ID	240	
GENERAL INFO	Utility	ELECTRIC			
	Size and Material	STANDARD POWER POLE, TIMBER			
	Utility Conflict Description	POLE WITHIN PROPOSED SIDEWALK			
	Longitudinal or Crossing	CROSSING			
	Placement Relative to ROW	INSIDE			
LOCATION	Sheet No.	326			
	Station Origin				
	Start Station	658+36.74	End Station		
	Start Offset	9.61	End Offset		
	Latitude	29.398168271	Longitude	-98.435053212	
SUE	Level of Investigation Req'd	NONE			
	Test Hole No	N/A			
	Test Hole Depth	N/A			
RESOLUTION	Recommended Action	ACCOMODATE - RELOCATION			
	Estimated Resolution Date				
	Resolution Status	UTILITY COORDINATION IN PROGRESS

Comment	INSUFFICIENT CLEARANCE PER PROWAG, 48" CLEARANCE REQUIRED. 34" BACK OF CURB TO FACE OF POLE, 15" POLE DIA, 34" BACK OF POLE TO ROW (BACK OF SIDEWALK)			
Date Collected		11/8/2017 3:56:39 PM	Date Modified		11/9/2017 5:45:01 PM
