Utility Conflict Report

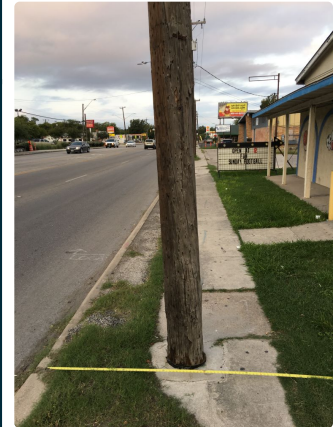
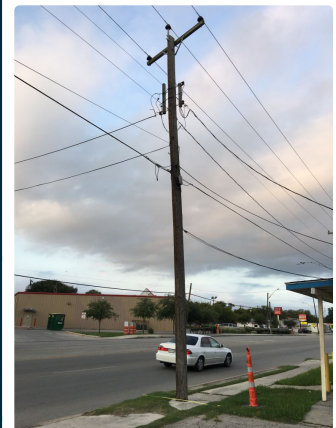
OWNER	Utility	CPS	Corridor	RIGSBY	SITE PHOTOS
	Contact	JAKE MARTINEZ	ID	242	
GENERAL INFO	Utility	ELECTRIC			
	Size and Material	STANDARD POWER POLE, TIMBER			
	Utility Conflict Description	POLE WITHIN PROPOSED SIDEWALK			
	Longitudinal or Crossing	CROSSING			
	Placement Relative to ROW	INSIDE			
LOCATION	Sheet No.	326			
	Station Origin				
	Start Station	657+44.16	End Station		
	Start Offset	9.59	End Offset		
	Latitude	29.398167097	Longitude	-98.434762503000002	
SUE	Level of Investigation Req'd	NONE			
	Test Hole No	N/A			
	Test Hole Depth	N/A			
RESOLUTION	Recommended Action	ACCOMODATE - RELOCATION			
	Estimated Resolution Date				
	Resolution Status	UTILITY COORDINATION IN PROGRESS

Comment	INSUFFICIENT CLEARANCE PER PROWAG, 48" CLEARANCE REQUIRED. 35" BACK OF CURB TO FACE OF POLE, 14" POLE DIA, 26" BACK OF POLE TO ROW (BACK OF SIDEWALK)			
Date Collected		11/8/2017 4:06:02 PM	Date Modified		11/9/2017 5:45:01 PM
