## Utility Conflict Report

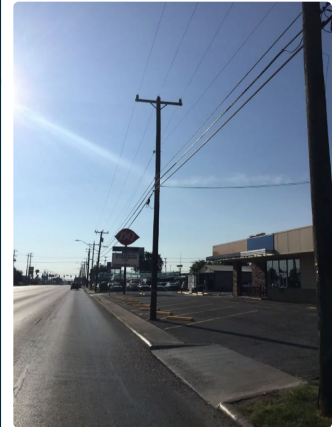
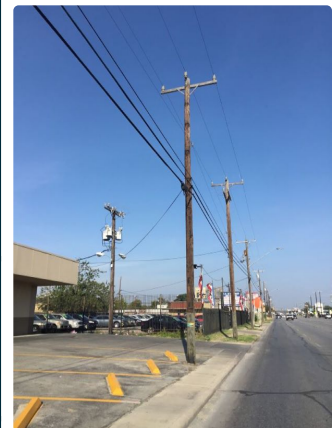
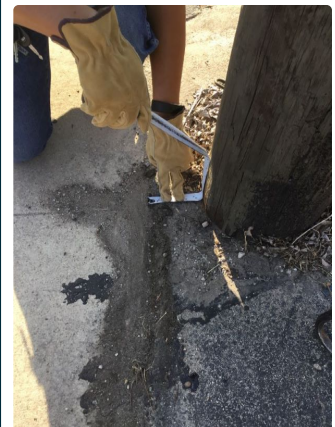
<b>OWNER</b>	<b>Utility</b>	CHARTER	<b>Corridor</b>	SW MILITARY	<b>SITE PHOTOS</b>
	<b>Contact</b>	FRANK CYPRIAN	<b>ID</b>	1040	
<b>GENERAL INFO</b>	<b>Utility</b>	COMMUNICATIONS			
	<b>Size and Material</b>	OVERHEAD TELECOMM LINES			
	<b>Accessible Route</b>	ASSET IS OUTSIDE ACCESSIBLE ROUTE			
	<b>Longitudinal or Crossing</b>	LONGITUDINAL			
	<b>Placement Relative to ROW</b>	INSIDE ROW			
<b>LOCATION</b>	<b>Sheet No.</b>	136			
	<b>Station</b>	558+42.45			
	<b>Offset</b>	15.99			
	<b>Latitude</b>	+29.357397			
	<b>Longitude</b>	-98.55147			
<b>SUE</b>	<b>Level of Investigation Req'd</b>	NONE			
	<b>Test Hole No</b>	N/A			
	<b>Test Hole Depth</b>	N/A			
<b>RESOLUTION</b>	<b>Recommended Action</b>	NO CONFLICT			
	<b>Estimated Resolution Date</b>				
	<b>Resolution Status</b>	NO RESOLUTION WAS REQUIRED			
	<b>Comment</b>	Related to utility ID 4116			
<b>Date Collected</b>		<b>Date Modified</b>		12/18/2018 4:04:41 PM
