## Utility Conflict Report

| <b>OWNER</b> | <b>Utility</b> | SAWS | <b>Corridor</b> | NOGALITOS | <b>SITE PHOTOS</b> | | |
| | <b>Contact</b> | ANN PECHE | <b>ID</b> | 3019 | | | |

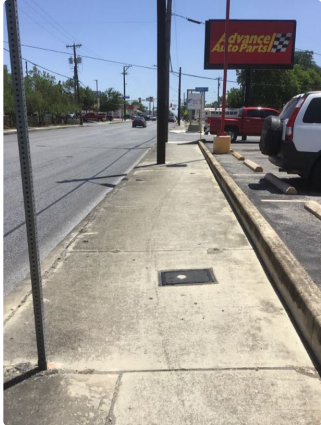
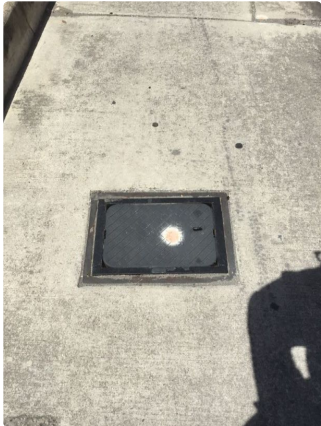
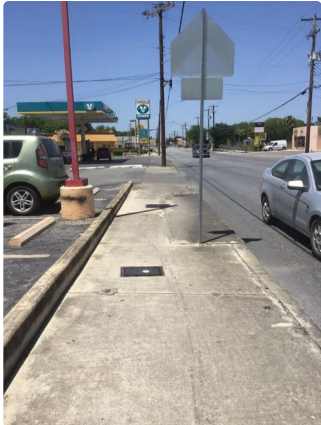
| | <b>Size and Material</b> | STANDARD WATER METER, CAST IRON | | | | | |
| | <b>Accessible Route</b> | ASSET IS INSIDE ACCESSIBLE ROUTE | | | | | |
| | <b>Comment</b> | Unable to open lid<br>Back of curb to meter = 3'-8"<br>Sidewalk width = 7'-0" | | | | | |

| <b>RESOLUTION</b> | <b>Recommended Action</b> | MINIMIZE - PROTECT IN PLACE | | | | | |
