Utility Conflict Report

| OWNER | Utility | CPS | Corridor | NOGALITOS | SITE PHOTOS |
| | Contact | JAKE MARTINEZ | ID | 3024 | |

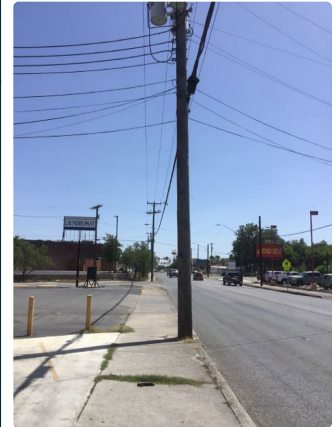
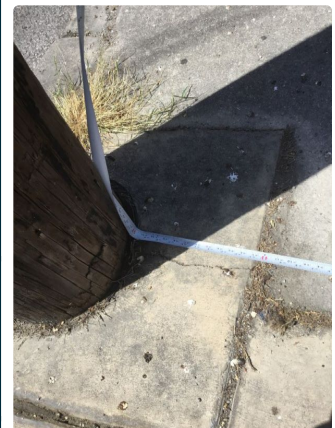
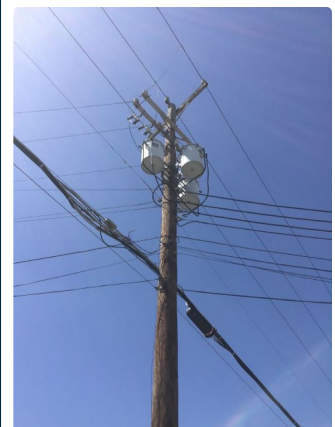
| | Size and Material | STANDARD POWER POLE, TIMBER | | | |
| | Accessible Route | ASSET IS INSIDE ACCESSIBLE ROUTE | | | |
| RESOLUTION | Recommended Action | NO CONFLICT | | | |
| | Comment | Pole to back of sidewalk = 5'-0" Pole diameter = 12" | | | |
