## Utility Conflict Report

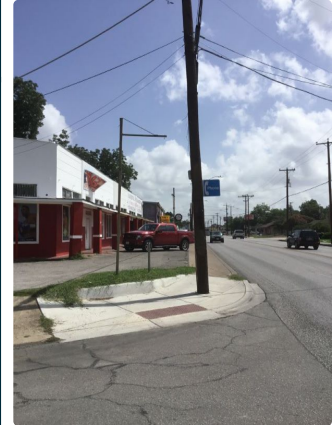
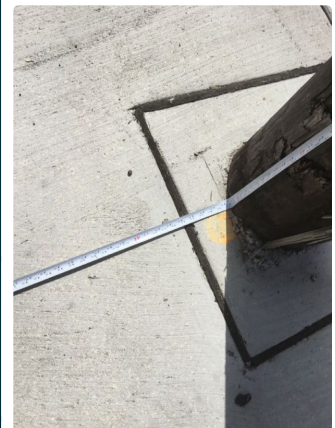
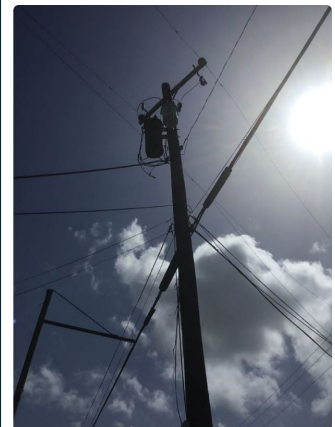
<b>OWNER</b>	<b>Utility</b>	CPS	<b>Corridor</b>	NOGALITOS	<b>SITE PHOTOS</b>		
	<b>Contact</b>	JAKE MARTINEZ	<b>ID</b>	3034			
<b>GENERAL INFO</b>	<b>Utility</b>	ELECTRIC					
	<b>Size and Material</b>	STANDARD POWER POLE, TIMBER					
	<b>Accessible Route</b>	ASSET IS INSIDE ACCESSIBLE ROUTE					
	<b>Longitudinal or Crossing</b>	CROSSING					
	<b>Placement Relative to ROW</b>	INSIDE ROW					
<b>LOCATION</b>	<b>Sheet No.</b>	82					
	<b>Station</b>	129+41.65					
	<b>Offset</b>	-27.19					
	<b>Latitude</b>	+29.392573					
	<b>Longitude</b>	-98.51865					
<b>SUE</b>	<b>Level of Investigation Req'd</b>	NONE					
	<b>Test Hole No</b>	N/A					
	<b>Test Hole Depth</b>	N/A					
<b>RESOLUTION</b>	<b>Recommended Action</b>	MINIMIZE - PROTECT IN PLACE					
	<b>Estimated Resolution Date</b>						
	<b>Resolution Status</b>	UTILITY OWNER INFORMED OF UTILITY					
	<b>Comment</b>	Pole marking: 2119 Pole to face of wall = 3'-10" Pole to back of curb = 3'-0"
