## Utility Conflict Report

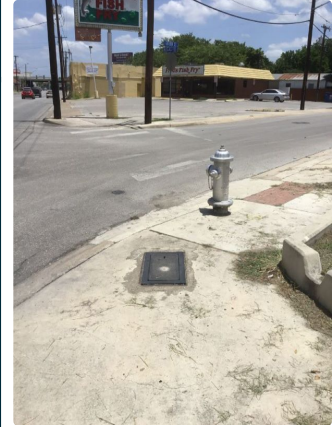
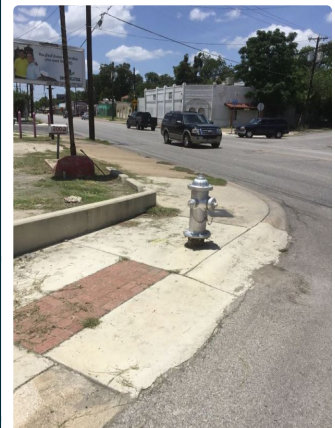
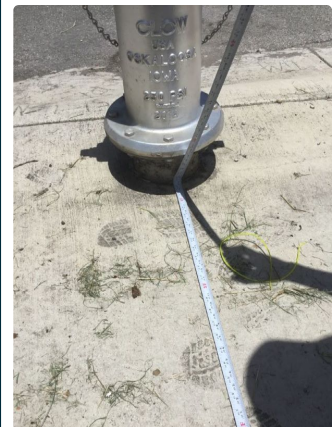
<b>OWNER</b>	<b>Utility</b>	SAWS	<b>Corridor</b>	NOGALITOS	<b>SITE PHOTOS</b>		
	<b>Contact</b>	NINA BITTLE	<b>ID</b>	3068			
<b>GENERAL INFO</b>	<b>Utility</b>	WATER					
	<b>Size and Material</b>	STANDARD FIRE HYDRANT					
	<b>Accessible Route</b>	ASSET IS INSIDE ACCESSIBLE ROUTE					
	<b>Longitudinal or Crossing</b>	CROSSING					
	<b>Placement Relative to ROW</b>	INSIDE ROW					
<b>LOCATION</b>	<b>Sheet No.</b>						
	<b>Station</b>	137+07.68					
	<b>Offset</b>	30.4671					
	<b>Latitude</b>	+29.394237					
	<b>Longitude</b>	-98.51705					
<b>SUE</b>	<b>Level of Investigation Req'd</b>	NONE					
	<b>Test Hole No</b>	N/A					
	<b>Test Hole Depth</b>	N/A					
<b>RESOLUTION</b>	<b>Recommended Action</b>	NO CONFLICT					
	<b>Estimated Resolution Date</b>	8/13/2018					
	<b>Resolution Status</b>	NO RESOLUTION WAS REQUIRED					
	<b>Comment</b>	Hydrant to face of wall = 4'-3" Sidewalk width = 5'-7"					
<b>Date Collected</b>		7/11/2018 1:23:31 PM		<b>Date Modified</b>		8/14/2018 4:38:26 PM
