## Utility Conflict Report

<b>OWNER</b>	<b>Utility</b>	CPS	<b>Corridor</b>	SW MILITARY	<b>SITE PHOTOS</b>	
	<b>Contact</b>	JAKE MARTINEZ	<b>ID</b>	3080		
<b>GENERAL INFO</b>	<b>Utility</b>	ELECTRIC

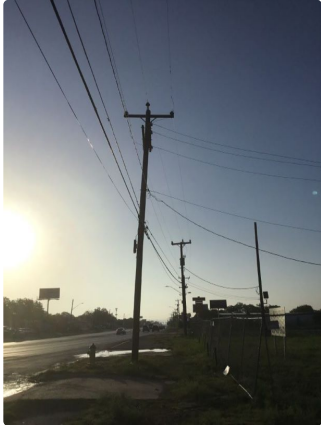
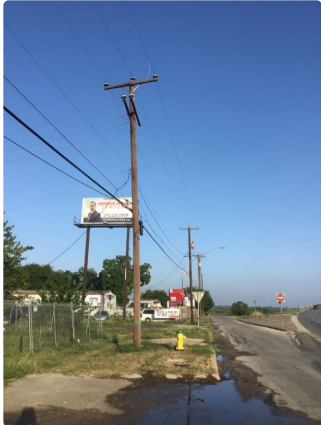
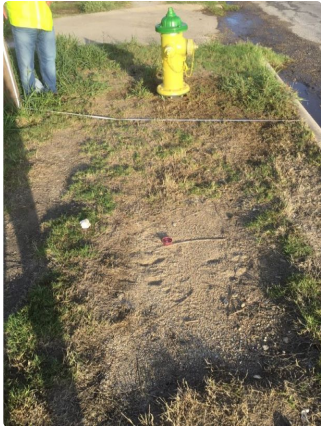
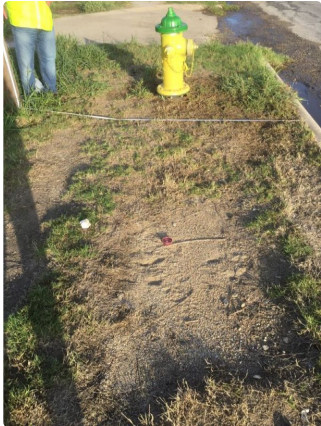
<b>Size and Material</b>	STANDARD POWER POLE, TIMBER				
	<b>Accessible Route</b>	ASSET IS INSIDE ACCESSIBLE ROUTE				
	<b>Longitudinal or Crossing</b>	CROSSING				
	<b>Placement Relative to ROW</b>	INSIDE ROW				
<b>LOCATION</b>	<b>Sheet No.</b>	120

<b>Estimated Resolution Date</b>	8/14/2018				
	<b>Resolution Status</b>	NO RESOLUTION WAS REQUIRED				
	<b>Comment</b>	Pole marking: 40_8 Pole to back of curb = 8'-7" Pole to cast iron box = 3'-0"

<b>Test Hole No</b>	N/A				
	<b>Test Hole Depth</b>	N/A				
<b>RESOLUTION</b>	<b>Recommended Action</b>	NO CONFLICT
