## Utility Conflict Report

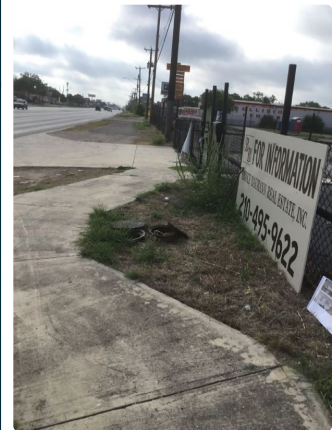
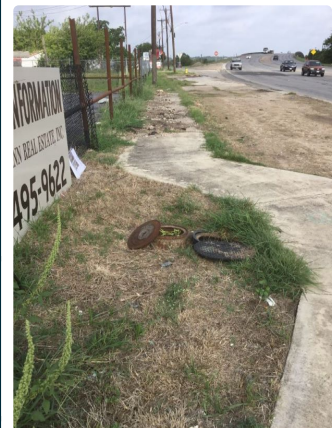
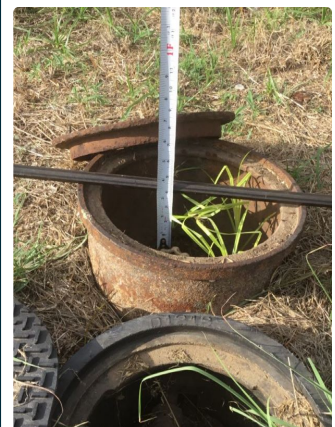
<b>OWNER</b>	<b>Utility</b>	SAWS	<b>Corridor</b>	SW MILITARY	<b>SITE PHOTOS</b>		
	<b>Contact</b>	ANN PECHE	<b>ID</b>	3085			
<b>GENERAL INFO</b>	<b>Utility</b>	WATER					
	<b>Size and Material</b>	STANDARD WATER VALVE, CAST IRON					
	<b>Accessible Route</b>	ASSET IS OUTSIDE ACCESSIBLE ROUTE					
	<b>Longitudinal or Crossing</b>	CROSSING					
	<b>Placement Relative to ROW</b>	INSIDE ROW					
<b>LOCATION</b>	<b>Sheet No.</b>	121					
	<b>Station</b>	508+31.93					
	<b>Offset</b>	28.3266					
	<b>Latitude</b>	+29.358857					
	<b>Longitude</b>	-98.56715					
<b>SUE</b>	<b>Level of Investigation Req'd</b>	NONE					
	<b>Test Hole No</b>	N/A					
	<b>Test Hole Depth</b>	N/A					
<b>RESOLUTION</b>	<b>Recommended Action</b>	NO CONFLICT					
	<b>Estimated Resolution Date</b>	8/14/2018					
	<b>Resolution Status</b>	NO RESOLUTION WAS REQUIRED					
	<b>Comment</b>	Edge of sidewalk to valve 2'-1" Top of valve to surface = 4" Lid thickness = 1 3/4" Sidewalk width = 5'
