## Utility Conflict Report

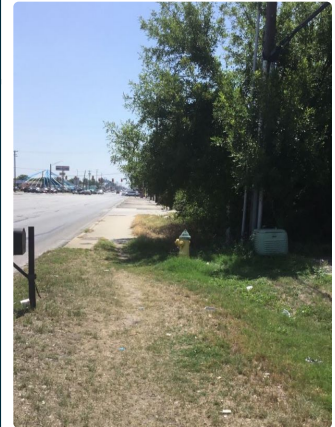
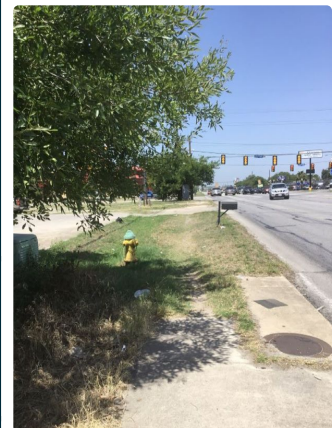
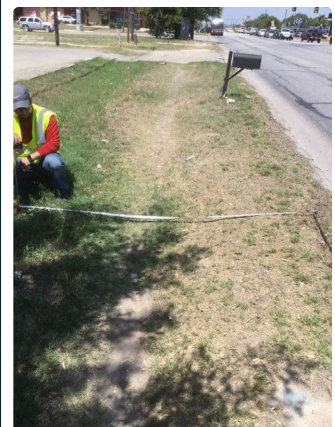
<b>OWNER</b>	<b>Utility</b>	SAWS	<b>Corridor</b>	SW MILITARY	<b>SITE PHOTOS</b>
	<b>Contact</b>	ANN PECHE	<b>ID</b>	3102	
<b>GENERAL INFO</b>	<b>Utility</b>	WATER			
	<b>Size and Material</b>	STANDARD FIRE HYDRANT			
	<b>Accessible Route</b>	ASSET IS INSIDE ACCESSIBLE ROUTE			
	<b>Longitudinal or Crossing</b>	CROSSING			
	<b>Placement Relative to ROW</b>	INSIDE ROW			
<b>LOCATION</b>	<b>Sheet No.</b>	128			
	<b>Station</b>	526+76.21			
	<b>Offset</b>	21.6183			
	<b>Latitude</b>	+29.358333			
	<b>Longitude</b>	-98.56133			
<b>SUE</b>	<b>Level of Investigation Req'd</b>	NONE			
	<b>Test Hole No</b>	N/A			
	<b>Test Hole Depth</b>	N/A			
<b>RESOLUTION</b>	<b>Recommended Action</b>	NO CONFLICT			
	<b>Estimated Resolution Date</b>	8/14/2018			
	<b>Resolution Status</b>	NO RESOLUTION WAS REQUIRED			
	<b>Comment</b>	Back of curb to hydrant = 8'-3" Curb covered under dirt			
<b>Date Collected</b>		7/19/2018 12:07:33 PM	<b>Date Modified</b>		11/28/2018 6:59:12 AM
