Utility Conflict Report

OWNER	Utility	CPS	Corridor	SW MILITARY	SITE PHOTOS	
	Contact	JAKE MARTINEZ	ID	3107		
GENERAL INFO	Utility	ELECTRIC

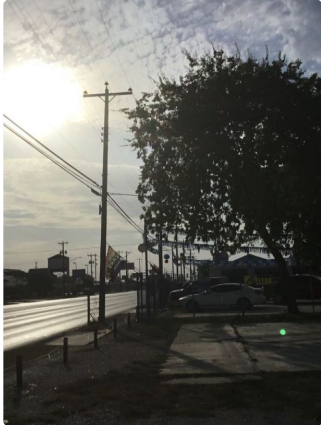
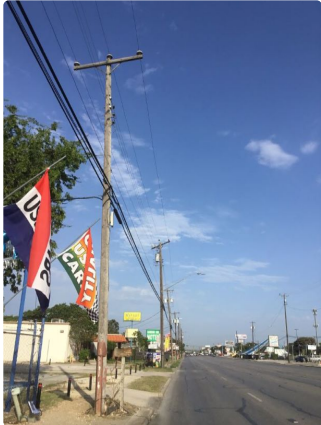
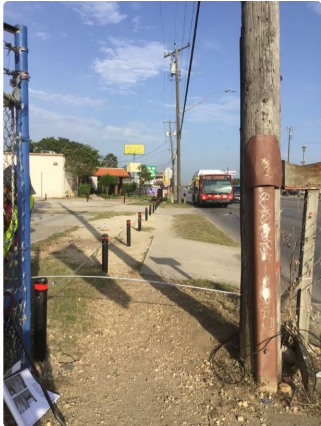
Size and Material	STANDARD POWER POLE, TIMBER				
	Accessible Route	ASSET IS INSIDE ACCESSIBLE ROUTE				
	Longitudinal or Crossing	CROSSING				
	Placement Relative to ROW	INSIDE ROW				
LOCATION	Sheet No.	132

Test Hole No	N/A				
	Test Hole Depth	N/A				
RESOLUTION	Recommended Action	NO CONFLICT				
	Estimated Resolution Date					
	Resolution Status	NO RESOLUTION WAS REQUIRED				
	Comment	Metal fence to pole = 4'-8" Back of curb inlet to pole = 2'-3" No pole ID				
Date Collected		7/24/2018 8:28:31 AM		Date Modified	11/28/2018 6:59:12 AM
