## Utility Conflict Report

<b>OWNER</b>	<b>Utility</b>	SAWS	<b>Corridor</b>	SW MILITARY	<b>SITE PHOTOS</b>		
	<b>Contact</b>	ANN PECHE	<b>ID</b>	3134			
<b>GENERAL INFO</b>	<b>Utility</b>	WATER

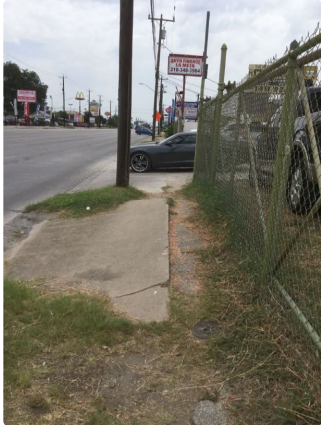
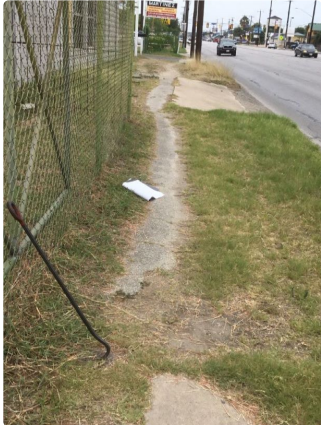
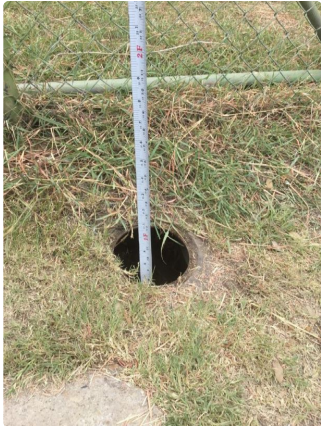
<b>Size and Material</b>	STANDARD WATER VALVE, CAST IRON					
	<b>Accessible Route</b>	ASSET IS INSIDE ACCESSIBLE ROUTE					
	<b>Longitudinal or Crossing</b>	CROSSING					
	<b>Placement Relative to ROW</b>	INSIDE ROW					
<b>LOCATION</b>	<b>Sheet No.</b>

<b>Test Hole No</b>	N/A					
	<b>Test Hole Depth</b>	N/A					
<b>RESOLUTION</b>	<b>Recommended Action</b>	NO CONFLICT					
	<b>Estimated Resolution Date</b>	11/21/2018					
	<b>Resolution Status</b>	NO RESOLUTION WAS REQUIRED					
	<b>Comment</b>	Top of valve to surface = 8" Lid thickness = 3/8" Back of storm inlet to valve = 6'-8"
