## Utility Conflict Report

<b>OWNER</b>	<b>Utility</b>	SAWS	<b>Corridor</b>	SW MILITARY	<b>SITE PHOTOS</b>	
	<b>Contact</b>	ANN PECHE	<b>ID</b>	3159		
<b>GENERAL INFO</b>	<b>Utility</b>	WATER

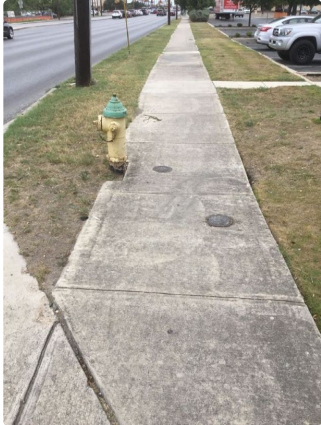
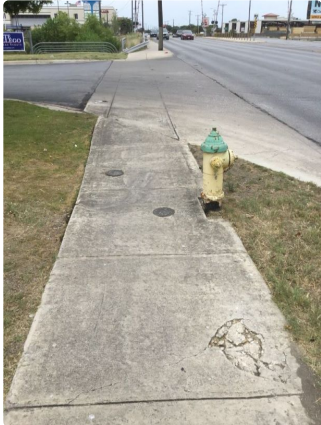
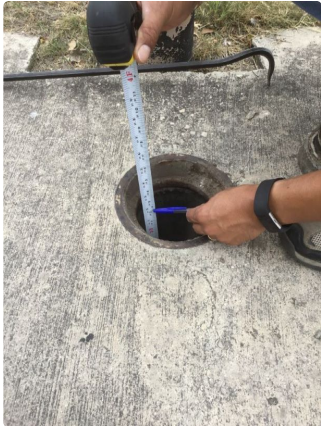
<b>Size and Material</b>	STANDARD WATER VALVE, CAST IRON				
	<b>Accessible Route</b>	ASSET IS INSIDE ACCESSIBLE ROUTE				
	<b>Longitudinal or Crossing</b>	CROSSING				
	<b>Placement Relative to ROW</b>	INSIDE ROW				
<b>LOCATION</b>	<b>Sheet No.</b>	175

<b>Test Hole No</b>	N/A				
	<b>Test Hole Depth</b>	N/A				
<b>RESOLUTION</b>	<b>Recommended Action</b>	NO CONFLICT				
	<b>Estimated Resolution Date</b>	9/17/2018				
	<b>Resolution Status</b>	NO RESOLUTION WAS REQUIRED				
	<b>Comment</b>	Valve to back of sidewalk = 2'-8" Hydrant to back of sidewalk = 4'-4 1/2" Sidewalk width = 5'-0" Top of valve to surface = 3'-2" Lid thickness = 1 1/2"
