## Utility Conflict Report

<b>OWNER</b>	<b>Utility</b>	CPS	<b>Corridor</b>	SW MILITARY	<b>SITE PHOTOS</b>	
	<b>Contact</b>	JAKE MARTINEZ	<b>ID</b>	3168		
<b>GENERAL INFO</b>	<b>Utility</b>	ELECTRIC

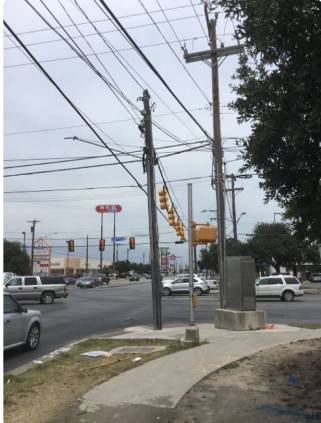
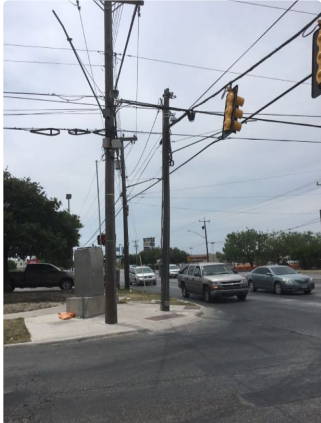
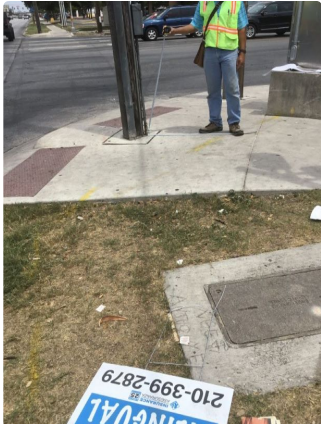
<b>Size and Material</b>	STANDARD POWER POLE, TIMBER				
	<b>Accessible Route</b>	ASSET IS INSIDE ACCESSIBLE ROUTE				
	<b>Longitudinal or Crossing</b>	CROSSING				
	<b>Placement Relative to ROW</b>	INSIDE ROW				
<b>LOCATION</b>	<b>Sheet No.</b>	146

<b>Estimated Resolution Date</b>					
	<b>Resolution Status</b>	NO RESOLUTION WAS REQUIRED				
	<b>Comment</b>	Pole conduit to ramp grade break (adjacent to electrical box pedestal) = 4'-7" No pole ID

<b>Test Hole No</b>	N/A				
	<b>Test Hole Depth</b>	N/A				
<b>RESOLUTION</b>	<b>Recommended Action</b>	NO CONFLICT
