## Utility Conflict Report

<b>OWNER</b>	<b>Utility</b>	SAWS	<b>Corridor</b>	BANDERA	<b>SITE PHOTOS</b>	
	<b>Contact</b>	ANN PECHE	<b>ID</b>	3192		
<b>GENERAL INFO</b>	<b>Utility</b>	WATER

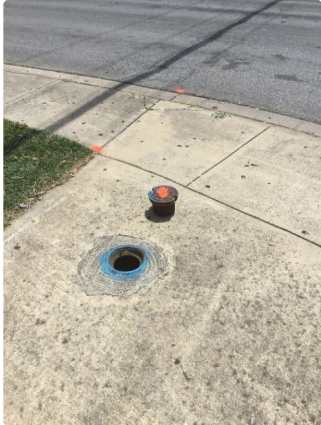
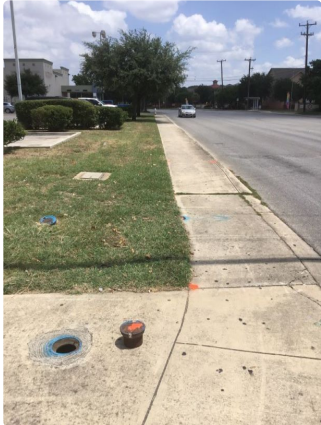
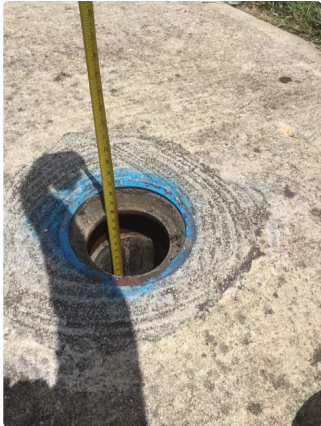
<b>Size and Material</b>	STANDARD WATER VALVE, CAST IRON				
	<b>Accessible Route</b>	ASSET IS OUTSIDE ACCESSIBLE ROUTE				
	<b>Longitudinal or Crossing</b>	CROSSING				
	<b>Placement Relative to ROW</b>	INSIDE ROW				
<b>LOCATION</b>	<b>Sheet No.</b>	270

<b>Station</b>	1467+12.70				
	<b>Offset</b>	45.13				
	<b>Latitude</b>	+29.515442				
	<b>Longitude</b>	-98.63426				
<b>SUE</b>	<b>Level of Investigation Req'd</b>	NONE				
	<b>Test Hole No</b>	N/A				
	<b>Test Hole Depth</b>	N/A				
<b>RESOLUTION</b>	<b>Recommended Action</b>	MINIMIZE - PROTECT IN PLACE

<b>Estimated Resolution Date</b>					
	<b>Resolution Status</b>	UTILITY OWNER INFORMED OF UTILITY				
	<b>Comment</b>	Lid thickness = 1 1/2" Back of sidewalk to valve = 2'-1 1/2" Top of valve to surface = 5'-3"
