Utility Conflict Report

OWNER	Utility	CPS	Corridor	BANDERA	SITE PHOTOS	
	Contact	BILL FEY	ID	3203		
GENERAL INFO	Utility	GAS

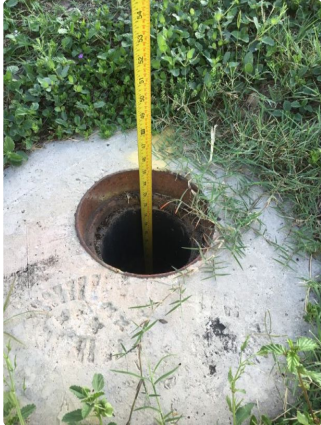
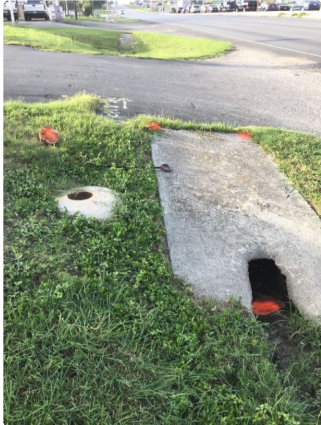
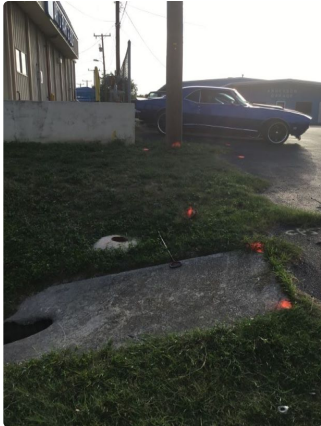
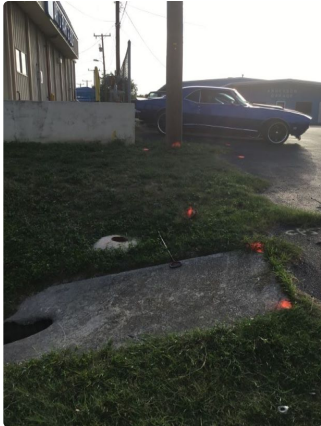
Size and Material	STANDARD GAS VALVE, CAST IRON				
	Accessible Route	ASSET IS OUTSIDE ACCESSIBLE ROUTE				
	Longitudinal or Crossing	CROSSING				
	Placement Relative to ROW	INSIDE ROW				
LOCATION	Sheet No.

Estimated Resolution Date	8/28/2018				
	Resolution Status	NO RESOLUTION WAS REQUIRED				
	Comment	Top of valve to surface = 3'-7" Edge of culvert concrete safety end treatment = 1'-9" Edge of driveway to valve = 4'-11 1/4" Lid thickness = 1 7/8"				
Date Collected		8/17/2018 8:24:51 AM		Date Modified	11/28/2018 6:59:12 AM

Test Hole No	N/A				
	Test Hole Depth	N/A				
RESOLUTION	Recommended Action	NO CONFLICT
