Utility Conflict Report

| OWNER | Utility | CPS | Corridor | BANDERA | SITE PHOTOS | |
| | Contact | BILL FEY | ID | 3212 | | |

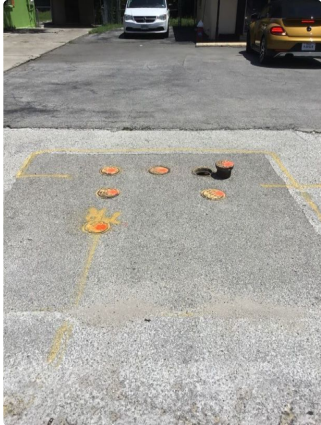
| RESOLUTION | Recommended Action | NO CONFLICT | | | | |
| | Comment | Gas valves Top of valve to surface = 0" (top right valve in first image) | | | | |
