## Utility Conflict Report

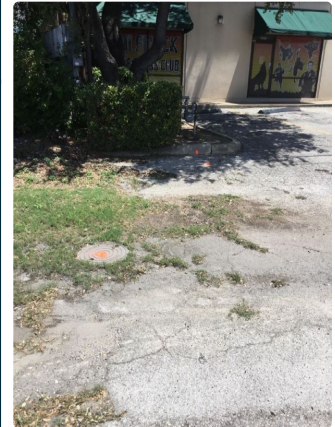
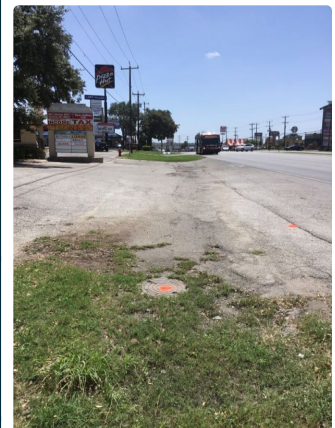
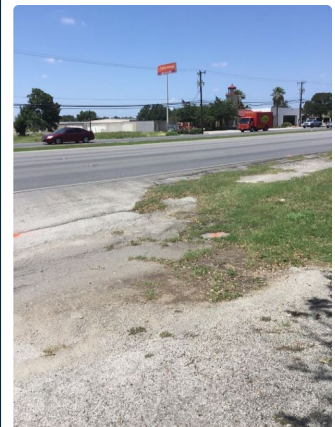
<b>OWNER</b>	<b>Utility</b>	SAWS	<b>Corridor</b>	BANDERA	<b>SITE PHOTOS</b>
	<b>Contact</b>	ANN PECHE	<b>ID</b>	3214	
<b>GENERAL INFO</b>	<b>Utility</b>	SANITARY SEWER			
	<b>Size and Material</b>	STANDARD MANHOLE, CAST IRON			
	<b>Accessible Route</b>	ASSET IS OUTSIDE ACCESSIBLE ROUTE			
	<b>Longitudinal or Crossing</b>	CROSSING			
	<b>Placement Relative to ROW</b>	INSIDE ROW			
<b>LOCATION</b>	<b>Sheet No.</b>				
	<b>Station</b>				
	<b>Offset</b>				
	<b>Latitude</b>	+29.501755			
	<b>Longitude</b>	-98.62538			
<b>SUE</b>	<b>Level of Investigation Req'd</b>	NONE			
	<b>Test Hole No</b>	N/A			
	<b>Test Hole Depth</b>	N/A			
<b>RESOLUTION</b>	<b>Recommended Action</b>	NO CONFLICT			
	<b>Estimated Resolution Date</b>	8/28/2018			
	<b>Resolution Status</b>	NO RESOLUTION WAS REQUIRED			
	<b>Comment</b>	Unable to open manhole			
<b>Date Collected</b>		8/17/2018 1:24:08 PM	<b>Date Modified</b>		11/28/2018 6:59:12 AM
