Utility Conflict Report

OWNER	Utility	SAWS	Corridor	BANDERA	SITE PHOTOS		
	Contact	ANN PECHE	ID	3244			
GENERAL INFO	Utility	WATER

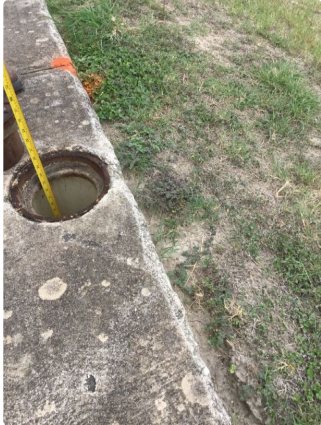
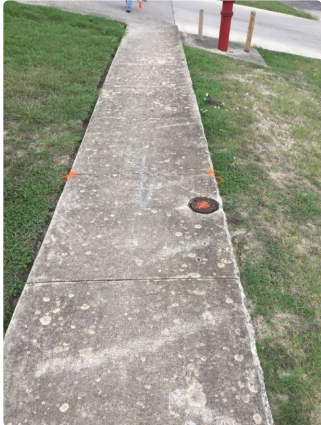
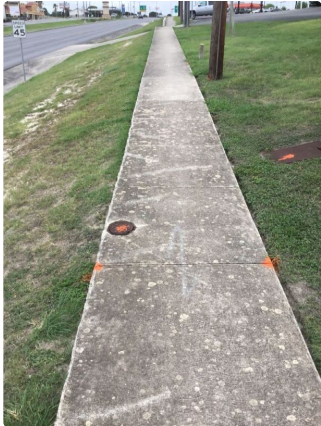
Size and Material	STANDARD WATER VALVE, CAST IRON					
	Accessible Route	ASSET IS INSIDE ACCESSIBLE ROUTE					
	Longitudinal or Crossing	CROSSING					
	Placement Relative to ROW	INSIDE ROW					
LOCATION	Sheet No.	299

Test Hole No	N/A					
	Test Hole Depth	N/A					
RESOLUTION	Recommended Action	MINIMIZE - PROTECT IN PLACE					
	Estimated Resolution Date						
	Resolution Status	UTILITY OWNER INFORMED OF UTILITY					
	Comment	Top of valve to surface = 2'-0" Lid thickness = 1 1/2" Front of sidewalk to valve = 1"					
Date Collected		8/20/2018 10:25:56 AM		Date Modified		12/19/2018 11:48:37 AM
