## Utility Conflict Report

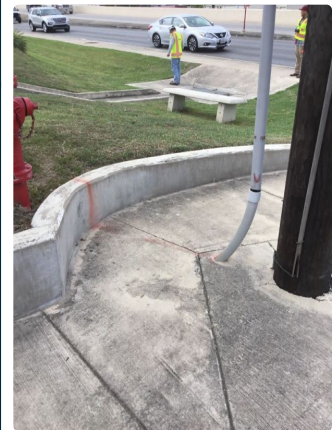
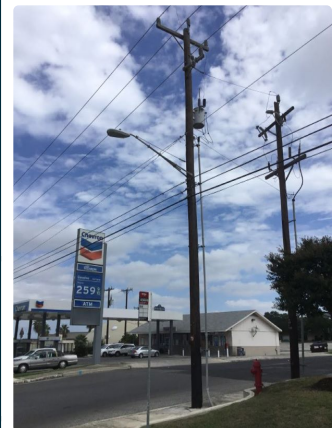
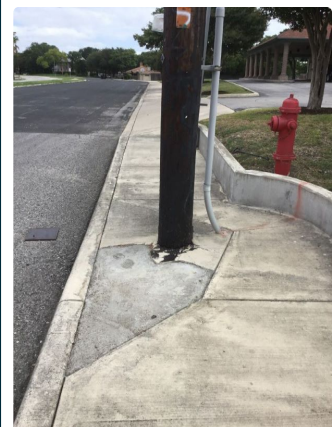
<b>OWNER</b>	<b>Utility</b>	CPS	<b>Corridor</b>	BANDERA	<b>SITE PHOTOS</b>
	<b>Contact</b>	JAKE MARTINEZ	<b>ID</b>	3251	
<b>GENERAL INFO</b>	<b>Utility</b>	ELECTRIC			
	<b>Size and Material</b>	STANDARD POWER POLE, TIMBER			
	<b>Accessible Route</b>	ASSET IS INSIDE ACCESSIBLE ROUTE			
	<b>Longitudinal or Crossing</b>	CROSSING			
	<b>Placement Relative to ROW</b>	INSIDE ROW			
<b>LOCATION</b>	<b>Sheet No.</b>				
	<b>Station</b>				
	<b>Offset</b>				
	<b>Latitude</b>	+29.488383			
	<b>Longitude</b>	-98.60886			
<b>SUE</b>	<b>Level of Investigation Req'd</b>	NONE			
	<b>Test Hole No</b>	N/A			
	<b>Test Hole Depth</b>	N/A			
<b>RESOLUTION</b>	<b>Recommended Action</b>	NO CONFLICT			
	<b>Estimated Resolution Date</b>	9/13/2018			
	<b>Resolution Status</b>	NO RESOLUTION WAS REQUIRED			
	<b>Comment</b>	Face of wall to PVC = 3'-1" No pole ID Pole diameter = 12"			
<b>Date Collected</b>		8/20/2018 11:15:53 AM		<b>Date Modified</b> 11/28/2018 6:59:12 AM
