Utility Conflict Report

OWNER	Utility	CPS	Corridor	BANDERA	SITE PHOTOS

Contact	BILL FEY	ID	3901		
GENERAL INFO	Utility	GAS

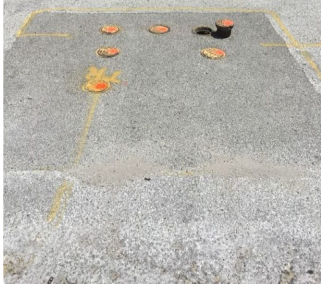
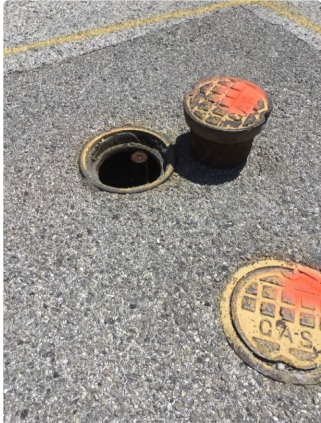
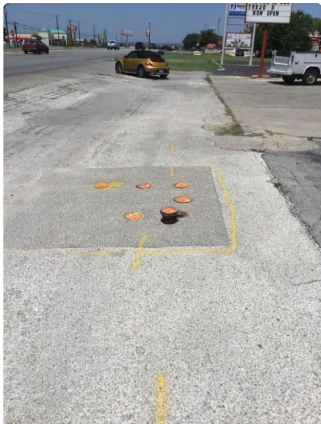
Size and Material	STANDARD GAS VALVE, CAST IRON				
	Accessible Route	ASSET IS OUTSIDE ACCESSIBLE ROUTE				
	Longitudinal or Crossing	CROSSING				
	Placement Relative to ROW	INSIDE ROW				
LOCATION	Sheet No.	246

Test Hole No	N/A				
	Test Hole Depth	N/A				
RESOLUTION	Recommended Action	MINIMIZE - PROTECT IN PLACE				
	Estimated Resolution Date					
	Resolution Status	UTILITY CONFLICT CREATED				
	Comment	Gas valves Top of valve to surface = 0" (top right valve in first image)				
Date Collected		8/17/2018 1:15:06 PM		Date Modified 11/21/2018 2:51:37 PM
