## Utility Conflict Report

<b>OWNER</b>	<b>Utility</b>	SAWS	<b>Corridor</b>	NOGALITOS	<b>SITE PHOTOS</b>	
	<b>Contact</b>	NINA BITTLE	<b>ID</b>	4019		
<b>GENERAL INFO</b>	<b>Utility</b>	WATER

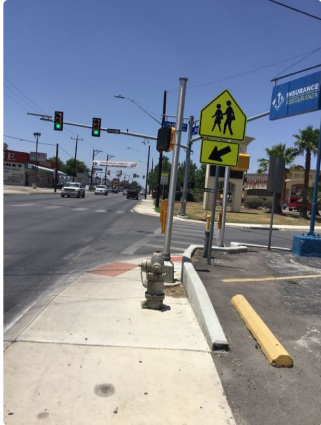
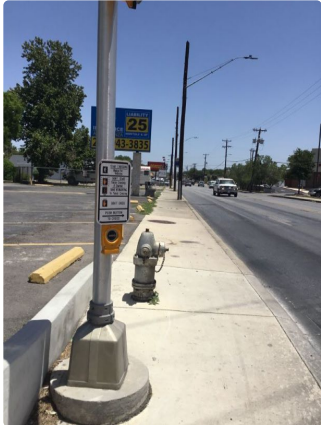
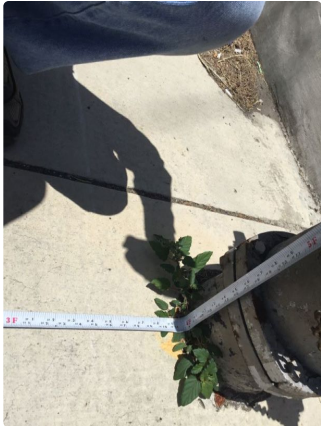
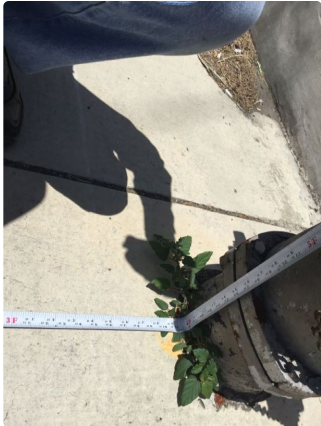
<b>Size and Material</b>	STANDARD FIRE HYDRANT				
	<b>Accessible Route</b>	ASSET IS INSIDE ACCESSIBLE ROUTE				
	<b>Longitudinal or Crossing</b>	CROSSING				
	<b>Placement Relative to ROW</b>	INSIDE ROW				
<b>LOCATION</b>	<b>Sheet No.</b>

<b>Estimated Resolution Date</b>	8/13/2018				
	<b>Resolution Status</b>	NO RESOLUTION WAS REQUIRED				
	<b>Comment</b>	Back of curb to hydrant = 4'-0"				
<b>Date Collected</b>		7/2/2018 12:49:15 PM		<b>Date Modified</b>	8/14/2018 4:38:26 PM

<b>Test Hole No</b>	N/A				
	<b>Test Hole Depth</b>	N/A				
<b>RESOLUTION</b>	<b>Recommended Action</b>	NO CONFLICT
