## Utility Conflict Report

<b>OWNER</b>	<b>Utility</b>	SAWS	<b>Corridor</b>	NOGALITOS	<b>SITE PHOTOS</b>

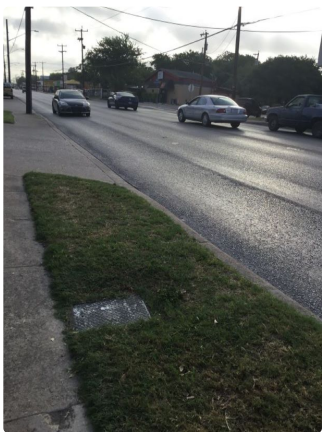
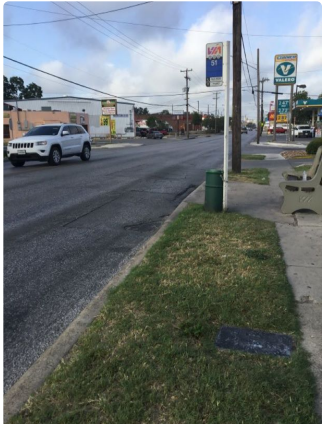
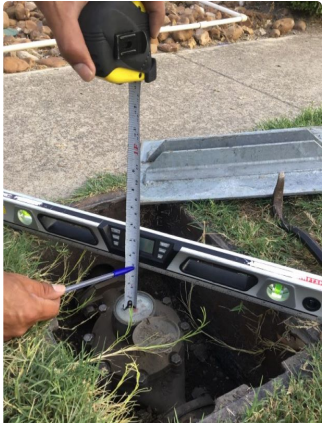
<b>Contact</b>	ANN PECHE	<b>ID</b>	4039	
<b>GENERAL INFO</b>	<b>Utility</b>	WATER			
	<b>Size and Material</b>	STANDARD WATER METER, STEEL			
	<b>Accessible Route</b>	ASSET IS OUTSIDE ACCESSIBLE ROUTE			
	<b>Longitudinal or Crossing</b>	CROSSING			
	<b>Placement Relative to ROW</b>	INSIDE ROW			
<b>LOCATION</b>	<b>Sheet No.</b>	115			
	<b>Station</b>	116+09.44			
	<b>Offset</b>	-26.01			
	<b>Latitude</b>	+29.389651			
	<b>Longitude</b>	-98.52119			
<b>SUE</b>	<b>Level of Investigation Req'd</b>	NONE			
	<b>Test Hole No</b>	N/A			
	<b>Test Hole Depth</b>	N/A			
<b>RESOLUTION</b>	<b>Recommended Action</b>	MINIMIZE - PROTECT IN PLACE			
	<b>Estimated Resolution Date</b>				
	<b>Resolution Status</b>	UTILITY OWNER INFORMED OF UTILITY			
	<b>Comment</b>	Top of valve to surface = 4" Sidewalk width = 2'-10"			
<b>Date Collected</b>		7/3/2018 7:58:53 AM		<b>Date Modified</b>	10/12/2018 3:14:06 PM
