## Utility Conflict Report

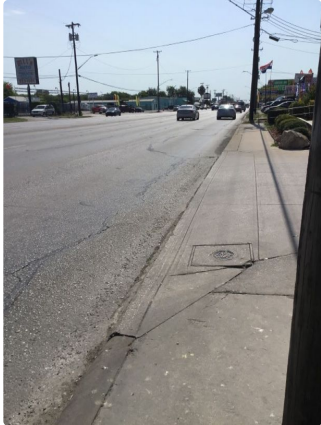
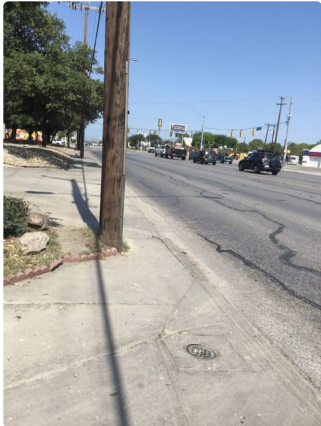
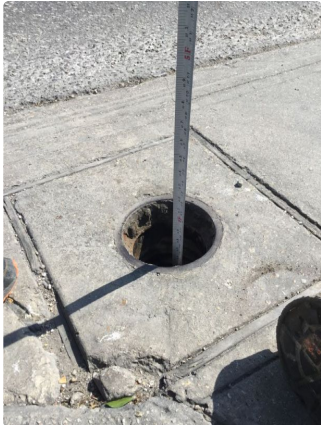
<b>OWNER</b>	<b>Utility</b>	SAWS	<b>Corridor</b>	SW MILITARY	<b>SITE PHOTOS</b>
	<b>Contact</b>	ANN PECHE	<b>ID</b>	4097	
<b>GENERAL INFO</b>	<b>Utility</b>	WATER			
	<b>Size and Material</b>	STANDARD WATER VALVE, CAST IRON			
	<b>Accessible Route</b>	ASSET IS INSIDE ACCESSIBLE ROUTE			
	<b>Longitudinal or Crossing</b>	CROSSING			
	<b>Placement Relative to ROW</b>	INSIDE ROW			
<b>LOCATION</b>	<b>Sheet No.</b>				
	<b>Station</b>	535+98.05			
	<b>Offset</b>	13.85			
	<b>Latitude</b>	+29.358077			
	<b>Longitude</b>	-98.55841			
<b>SUE</b>	<b>Level of Investigation Req'd</b>	NONE			
	<b>Test Hole No</b>	N/A			
	<b>Test Hole Depth</b>	N/A			
<b>RESOLUTION</b>	<b>Recommended Action</b>	NO CONFLICT			
	<b>Estimated Resolution Date</b>	11/21/2018			
	<b>Resolution Status</b>	NO RESOLUTION WAS REQUIRED			
	<b>Comment</b>	Back of curb to valve = 1'-1" Valve to front of sidewalk = 8" Top of valve to surface = 3'-8" Lid thickness = 2" Sidewalk width = 7'-6"
