Utility Conflict Report

OWNER	Utility	SAWS	Corridor	SW MILITARY	SITE PHOTOS	
	Contact	ANN PECHE	ID	4124		
GENERAL INFO	Utility	WATER

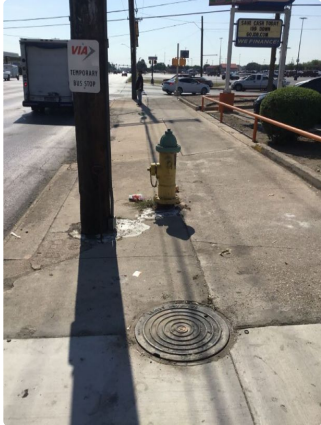
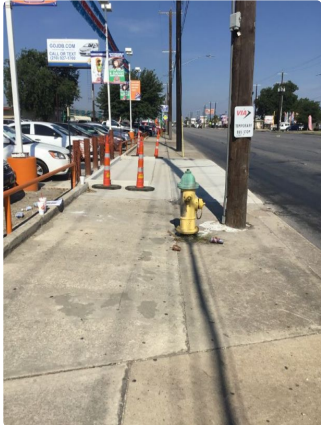
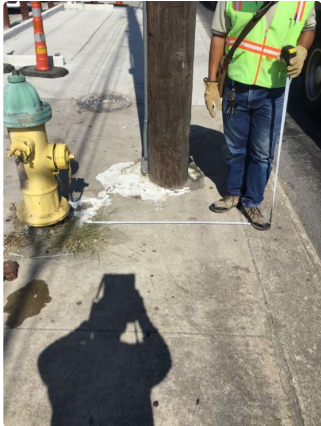
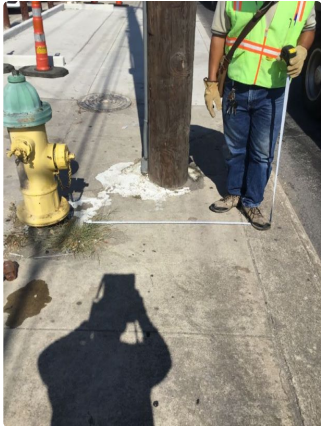
Size and Material	STANDARD FIRE HYDRANT				
	Accessible Route	ASSET IS INSIDE ACCESSIBLE ROUTE				
	Longitudinal or Crossing	CROSSING				
	Placement Relative to ROW	INSIDE ROW				
LOCATION	Sheet No.	138

Estimated Resolution Date					
	Resolution Status	NO RESOLUTION WAS REQUIRED				
	Comment	Hydrant to back of curb inlet = 3'-8" Back of curb inlet to face of curb = 11'-7" Adjacent to VIA temporary bus stop				
Date Collected		7/27/2018 10:13:10 AM		Date Modified	11/28/2018 6:59:12 AM

Test Hole No	N/A				
	Test Hole Depth	N/A				
RESOLUTION	Recommended Action	NO CONFLICT
