## Utility Conflict Report

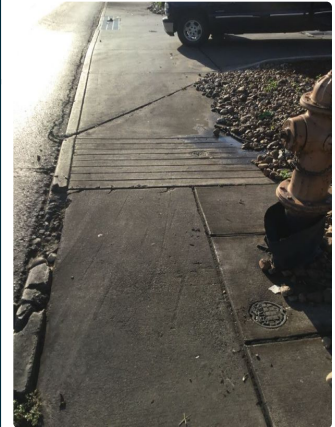
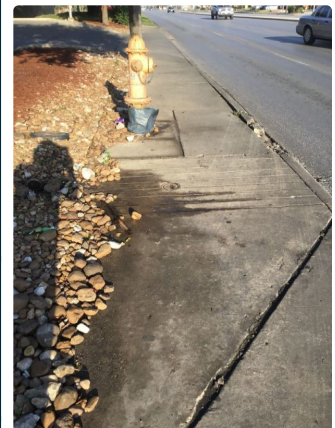
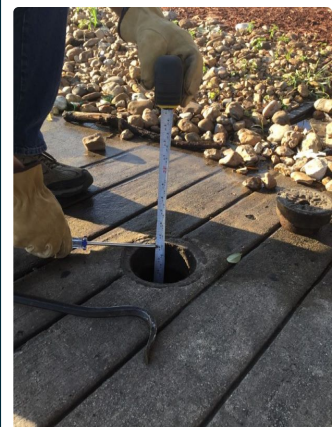
<b>OWNER</b>	<b>Utility</b>	SAWS	<b>Corridor</b>	SW MILITARY	<b>SITE PHOTOS</b>
	<b>Contact</b>	ANN PECHE	<b>ID</b>	4131	
<b>GENERAL INFO</b>	<b>Utility</b>	WATER			
	<b>Size and Material</b>	STANDARD WATER VALVE, CAST IRON			
	<b>Accessible Route</b>	ASSET IS INSIDE ACCESSIBLE ROUTE			
	<b>Longitudinal or Crossing</b>	CROSSING			
	<b>Placement Relative to ROW</b>	INSIDE ROW			
<b>LOCATION</b>	<b>Sheet No.</b>	148			
	<b>Station</b>	636+55.82			
	<b>Offset</b>	18.56			
	<b>Latitude</b>	+29.356503			
	<b>Longitude</b>	-98.52698			
<b>SUE</b>	<b>Level of Investigation Req'd</b>	NONE			
	<b>Test Hole No</b>	N/A			
	<b>Test Hole Depth</b>	N/A			
<b>RESOLUTION</b>	<b>Recommended Action</b>	MINIMIZE - PROTECT IN PLACE			
	<b>Estimated Resolution Date</b>				
	<b>Resolution Status</b>	UTILITY OWNER INFORMED OF UTILITY			
	<b>Comment</b>	Valve to back of curb = 3'-9"			
		Sidewalk width = 6'-8"			
		Valve box appears to be abandoned and filled with dirt

Top of dirt to surface = 1'-5"			
		Lid thickness = 1 3/4"			
<b>Date Collected</b>		8/1/2018 8:13:23 AM		<b>Date Modified</b>	11/28/2018 6:59:12 AM
