Utility Conflict Report

| OWNER | Utility | CPS | Corridor | SW MILITARY | SITE PHOTOS | | |
| | Contact | JAKE MARTINEZ | ID | 4139 | | | |

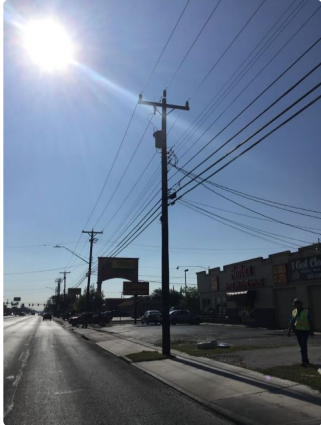
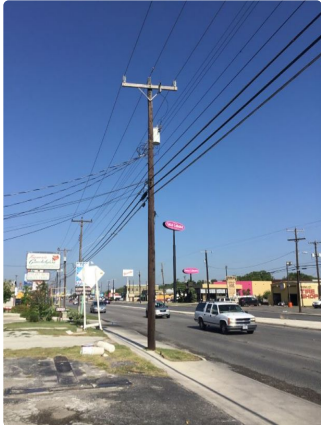
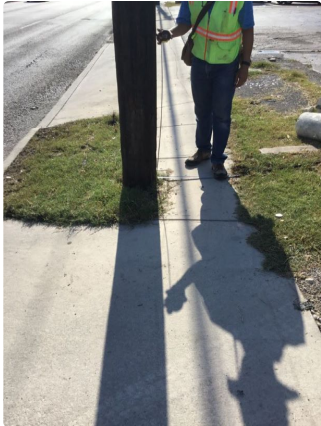
| | Size and Material | STANDARD POWER POLE, TIMBER | | | | | |
| | Accessible Route | ASSET IS INSIDE ACCESSIBLE ROUTE | | | | | |
| RESOLUTION | Recommended Action | NO CONFLICT | | | | | |
| | Resolution Status | NO RESOLUTION WAS REQUIRED | | | | | |
| | Comment | Pole marking: 1608 Pole to back of sidewalk = 2'-7" Sidewalk width = 3'-2" Pole to back of curb = 3'-11" | | | | | |
