Utility Conflict Report

OWNER	Utility	SAWS	Corridor	SW MILITARY	SITE PHOTOS	
	Contact	ANN PECHE	ID	4155		
GENERAL INFO	Utility	WATER

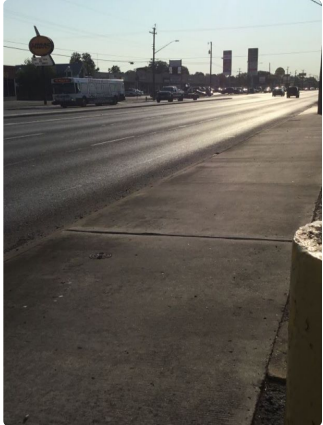
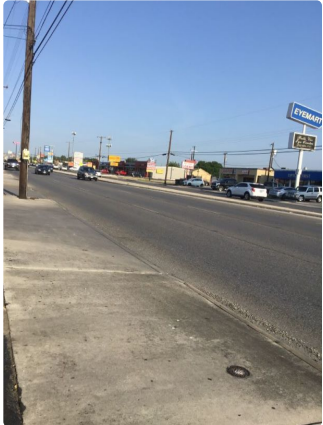
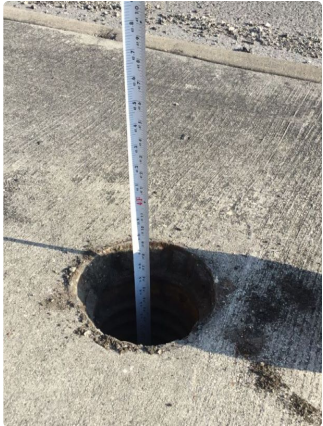
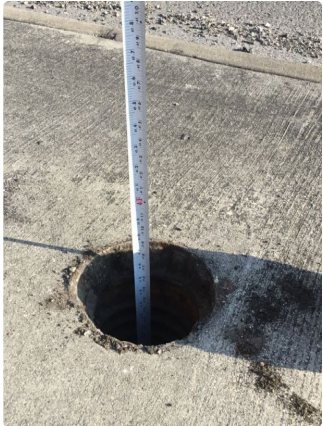
Size and Material	STANDARD WATER VALVE, CAST IRON				
	Accessible Route	ASSET IS INSIDE ACCESSIBLE ROUTE				
	Longitudinal or Crossing	CROSSING				
	Placement Relative to ROW	INSIDE ROW				
LOCATION	Sheet No.	156

Comment	Back of curb to valve = 2'-3.5" Sidewalk width = 8'-2" Back of sidewalk to valve = 5'-3" Top of valve to surface = 3'-8" Lid flange thickness = 2" Total lid thickness = 3.5"				
Date Collected		8/2/2018 8:41:45 AM		Date Modified 11/28/2018 6:59:12 AM

Test Hole No	N/A				
	Test Hole Depth	N/A				
RESOLUTION	Recommended Action	MINIMIZE - PROTECT IN PLACE
