## Utility Conflict Report

<b>OWNER</b>	<b>Utility</b>	CPS	<b>Corridor</b>	SW MILITARY	<b>SITE PHOTOS</b>	
	<b>Contact</b>	JAKE MARTINEZ	<b>ID</b>	4159		
<b>GENERAL INFO</b>	<b>Utility</b>	ELECTRIC

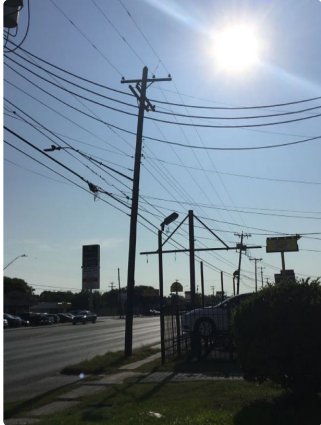
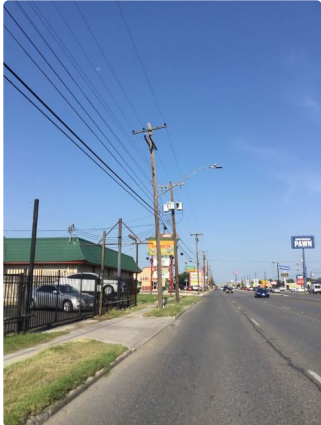
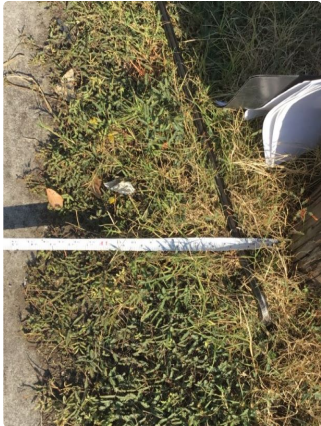
<b>Size and Material</b>	STANDARD POWER POLE, TIMBER				
	<b>Accessible Route</b>	ASSET IS INSIDE ACCESSIBLE ROUTE				
	<b>Longitudinal or Crossing</b>	CROSSING				
	<b>Placement Relative to ROW</b>	INSIDE ROW				
<b>LOCATION</b>	<b>Sheet No.</b>	155

<b>Estimated Resolution Date</b>					
	<b>Resolution Status</b>	NO RESOLUTION WAS REQUIRED				
	<b>Comment</b>	Pole ID: 508150; LW 48489 Back of curb to pole = 3'-4" Front of sidewalk to pole = 2" Sidewalk width = 4'

<b>Test Hole No</b>	N/A				
	<b>Test Hole Depth</b>	N/A				
<b>RESOLUTION</b>	<b>Recommended Action</b>	NO CONFLICT
