## Utility Conflict Report

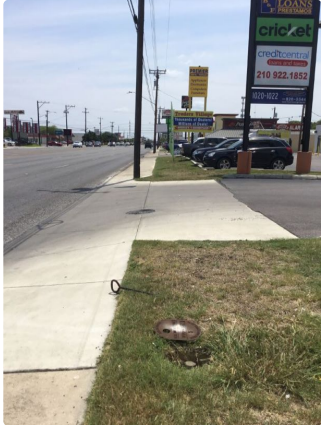
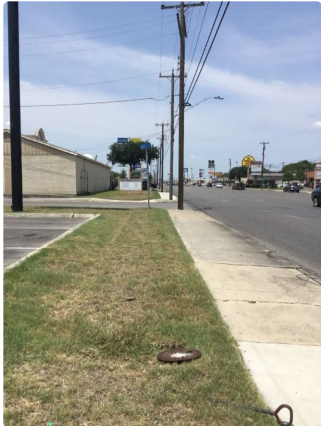
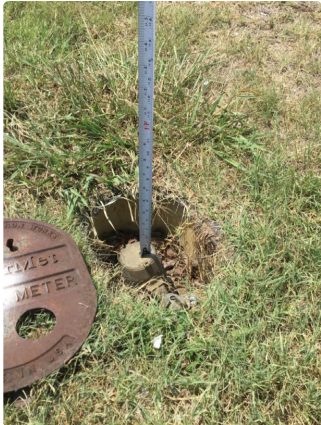
<b>OWNER</b>	<b>Utility</b>	SAWS	<b>Corridor</b>	SW MILITARY	<b>SITE PHOTOS</b>
	<b>Contact</b>	ANN PECHE	<b>ID</b>	4174	
<b>GENERAL INFO</b>	<b>Utility</b>	WATER			
	<b>Size and Material</b>	STANDARD WATER METER, CAST IRON			
	<b>Accessible Route</b>	ASSET IS OUTSIDE ACCESSIBLE ROUTE			
	<b>Longitudinal or Crossing</b>	CROSSING			
	<b>Placement Relative to ROW</b>	INSIDE ROW			
<b>LOCATION</b>	<b>Sheet No.</b>				
	<b>Station</b>	694+20.39			
	<b>Offset</b>	20.8622			
	<b>Latitude</b>	+29.356649			
	<b>Longitude</b>	-98.50887			
<b>SUE</b>	<b>Level of Investigation Req'd</b>	NONE			
	<b>Test Hole No</b>	N/A			
	<b>Test Hole Depth</b>	N/A			
<b>RESOLUTION</b>	<b>Recommended Action</b>	NO CONFLICT			
	<b>Estimated Resolution Date</b>				
	<b>Resolution Status</b>	NO RESOLUTION WAS REQUIRED			
	<b>Comment</b>	Back of sidewalk to meter = 1'-2" Sidewalk width = 6'-0" Top of meter to surface = 1" Lid flange thickness = 3/8" Total lid thickness = 1 3/4"
