## Utility Conflict Report

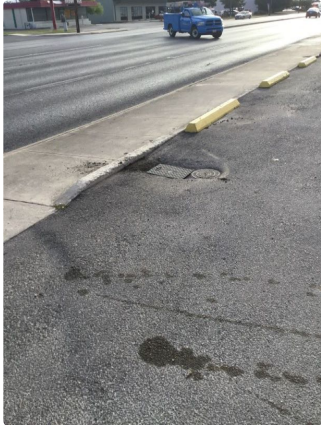
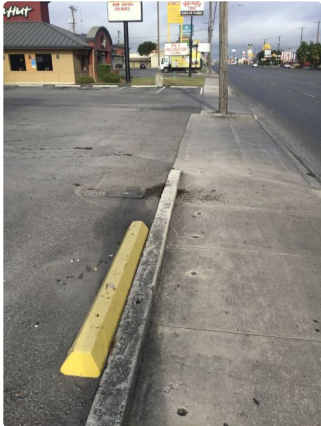
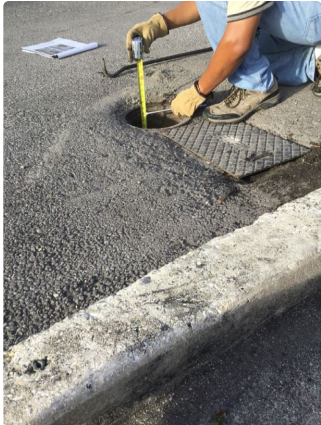
<b>OWNER</b>	<b>Utility</b>	SAWS	<b>Corridor</b>	SW MILITARY	<b>SITE PHOTOS</b>
	<b>Contact</b>	ANN PECHE	<b>ID</b>	4182	
<b>GENERAL INFO</b>	<b>Utility</b>	WATER			
	<b>Size and Material</b>	STANDARD WATER VALVE, CAST IRON			
	<b>Accessible Route</b>	ASSET IS OUTSIDE ACCESSIBLE ROUTE			
	<b>Longitudinal or Crossing</b>	CROSSING			
	<b>Placement Relative to ROW</b>	INSIDE ROW			
<b>LOCATION</b>	<b>Sheet No.</b>	160			
	<b>Station</b>	697+94.97			
	<b>Offset</b>	23.3466			
	<b>Latitude</b>	+29.356418			
	<b>Longitude</b>	-98.50774			
<b>SUE</b>	<b>Level of Investigation Req'd</b>	NONE			
	<b>Test Hole No</b>	N/A			
	<b>Test Hole Depth</b>	N/A			
<b>RESOLUTION</b>	<b>Recommended Action</b>	NO CONFLICT			
	<b>Estimated Resolution Date</b>				
	<b>Resolution Status</b>	NO RESOLUTION WAS REQUIRED			
	<b>Comment</b>	Top of valve to surface = 10" Hand hole cover diameter = 12" Lid flange thickness = 1/2" Overall lid thickness = 1 3/4" Box filled with dirt Meter to back of sidewalk/face of curb = 2'-10" Sidewalk width = 6'-6"
