## Utility Conflict Report

<b>OWNER</b>	<b>Utility</b>	SAWS	<b>Corridor</b>	SW MILITARY	<b>SITE PHOTOS</b>		
	<b>Contact</b>	ANN PECHE	<b>ID</b>	4209			
<b>GENERAL INFO</b>	<b>Utility</b>	WATER

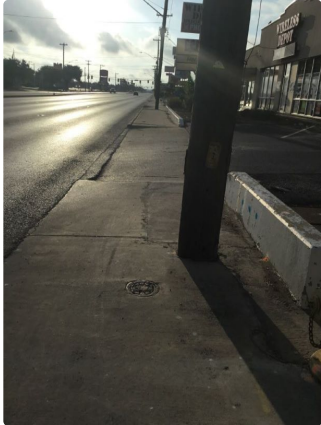
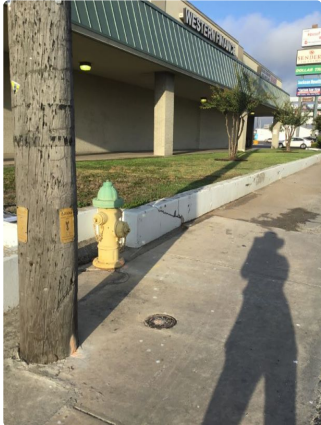
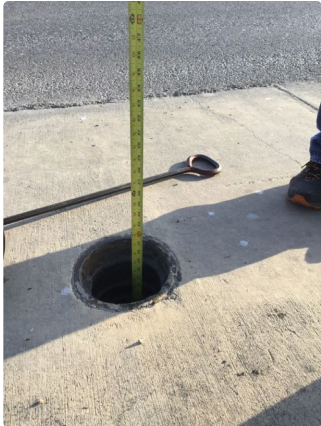
<b>Size and Material</b>	STANDARD WATER VALVE, CAST IRON					
	<b>Accessible Route</b>	ASSET IS INSIDE ACCESSIBLE ROUTE					
	<b>Longitudinal or Crossing</b>	CROSSING					
	<b>Placement Relative to ROW</b>	INSIDE ROW					
<b>LOCATION</b>	<b>Sheet No.</b>	166

<b>Test Hole No</b>	N/A					
	<b>Test Hole Depth</b>	N/A					
<b>RESOLUTION</b>	<b>Recommended Action</b>	MINIMIZE - PROTECT IN PLACE					
	<b>Estimated Resolution Date</b>						
	<b>Resolution Status</b>	UTILITY OWNER INFORMED OF UTILITY					
	<b>Comment</b>	Edge of pavement to valve = 3'-1" Back of sidewalk to valve = 2'-11" Sidewalk width = 6'-9" Top of valve to surface = 2'-6" Lid flange thickness = 2" Overall lid thickness = 3"
