Utility Conflict Report

OWNER	Utility	CPS	Corridor	BANDERA	<div style="border: 1px solid black; padding: 5px; text-align: center;">SITE PHOTOS</div>

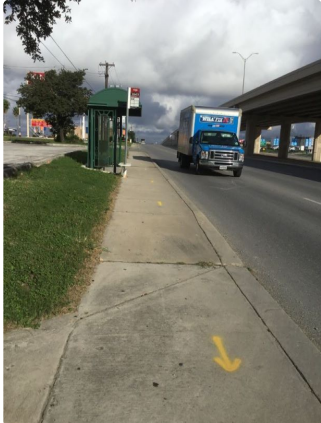
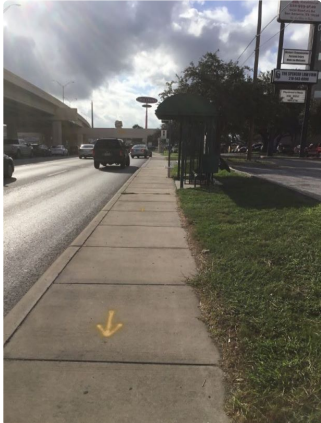
Contact	BILL FEY	ID	4580			
GENERAL INFO	Utility	GAS					
	Size and Material	UNKNOWN					
	Accessible Route	ASSET IS INSIDE ACCESSIBLE ROUTE					
	Longitudinal or Crossing	LONGITUDINAL					
	Placement Relative to ROW	INSIDE ROW					
LOCATION	Sheet No.	296					
	Station	1723+20					
	Offset	-20					
	Latitude	+29.485174					
	Longitude	-98.60613					
SUE	Level of Investigation Req'd	QLA					
	Test Hole No	N/A					
	Test Hole Depth	N/A					
RESOLUTION	Recommended Action	ACCOMODATE - RELOCATION					
	Estimated Resolution Date						
	Resolution Status	UTILITY OWNER INFORMED OF UTILITY

Comment	811 - Underground gas and electric/cable lines. Request As-builts for line depth verification					
Date Collected		11/20/2018 10:43:52 AM		Date Modified		12/19/2018 11:48:32 AM
