## Utility Conflict Report

<b>OWNER</b>	<b>Utility</b>	SAWS	<b>Corridor</b>	MILITARY	<b>SITE PHOTOS</b>	
	<b>Contact</b>	ANN PECHE	<b>ID</b>	7010		
<b>GENERAL INFO</b>	<b>Utility</b>	WATER

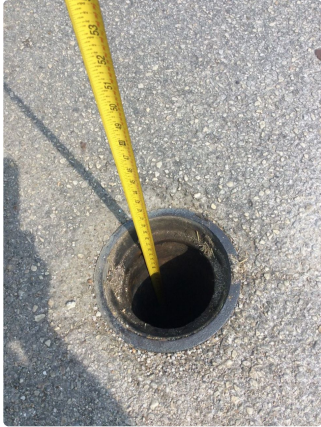
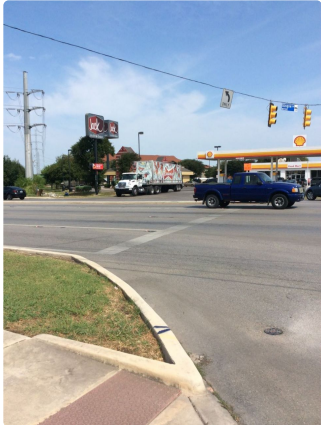
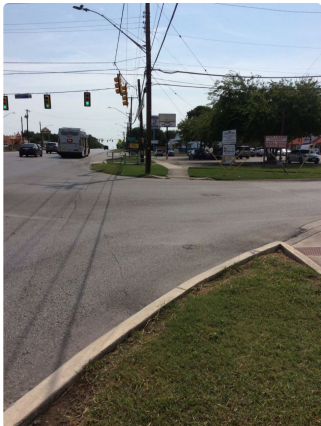
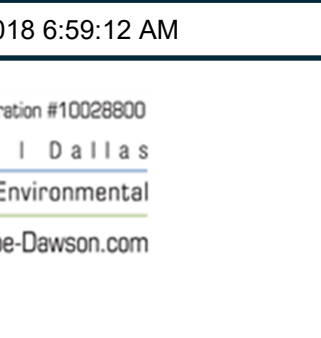
<b>Size and Material</b>	STANDARD WATER VALVE, CAST IRON				
	<b>Accessible Route</b>	ASSET IS OUTSIDE ACCESSIBLE ROUTE				
	<b>Longitudinal or Crossing</b>	CROSSING				
	<b>Placement Relative to ROW</b>	INSIDE ROW				
<b>LOCATION</b>	<b>Sheet No.</b>	227

<b>Estimated Resolution Date</b>	8/13/2018				
	<b>Resolution Status</b>	NO RESOLUTION WAS REQUIRED				
	<b>Comment</b>	Top of valve to surface = 3'-5" Face of curb to valve = 3'-5" Valve located in right turn lane

<b>Test Hole No</b>	N/A				
	<b>Test Hole Depth</b>	N/A				
<b>RESOLUTION</b>	<b>Recommended Action</b>	NO CONFLICT
