Utility Conflict Report

OWNER	Utility	SAWS	Corridor	MILITARY	SITE PHOTOS	
	Contact	ANN PECHE	ID	7015		
GENERAL INFO	Utility	WATER

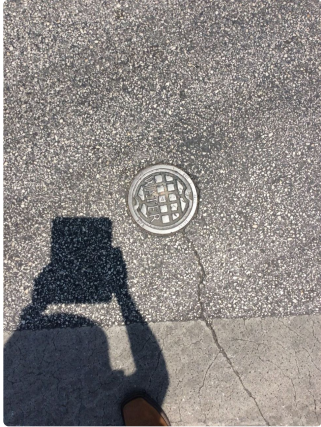
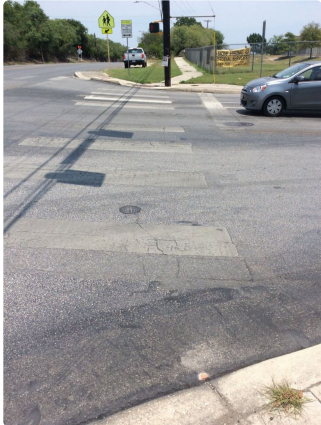
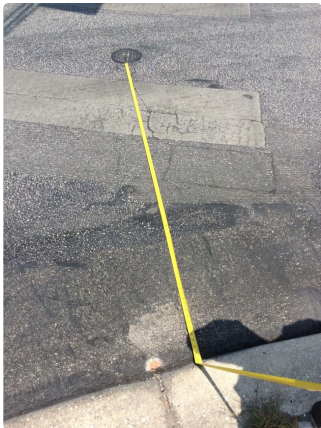
Size and Material	STANDARD WATER VALVE, CAST IRON				
	Accessible Route	ASSET IS INSIDE ACCESSIBLE ROUTE				
	Longitudinal or Crossing	CROSSING				
	Placement Relative to ROW	INSIDE ROW				
LOCATION	Sheet No.	217

Estimated Resolution Date	12/18/2018				
	Resolution Status	NO RESOLUTION WAS REQUIRED				
	Comment	Water valve in middle of right turn lane Unable to open lid Face of curb to valve = 7'-6" Raise valve cover flush with pavement improvements				
Date Collected		8/2/2018 1:48:36 PM	Date Modified		12/18/2018 3:35:10 PM
