## Utility Conflict Report

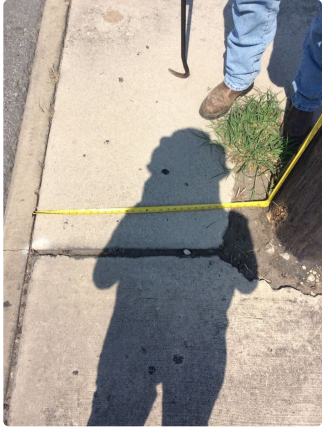
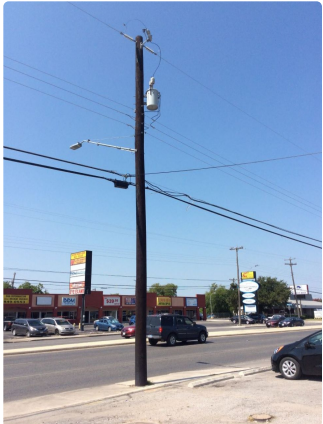
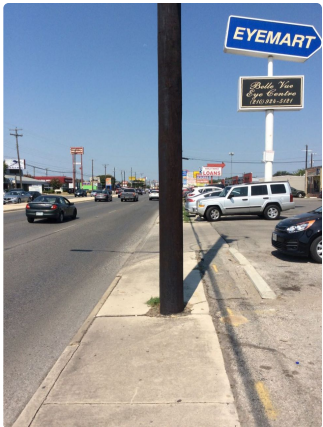
<b>OWNER</b>	<b>Utility</b>	CPS	<b>Corridor</b>	SW MILITARY	<b>SITE PHOTOS</b>	
	<b>Contact</b>	JAKE MARTINEZ	<b>ID</b>	7062		
<b>GENERAL INFO</b>	<b>Utility</b>	ELECTRIC				
	<b>Size and Material</b>	STANDARD POWER POLE, TIMBER				
	<b>Accessible Route</b>	ASSET IS INSIDE ACCESSIBLE ROUTE				
	<b>Longitudinal or Crossing</b>	CROSSING				
	<b>Placement Relative to ROW</b>	INSIDE ROW				
<b>LOCATION</b>	<b>Sheet No.</b>	204				
	<b>Station</b>	909+20.32				
	<b>Offset</b>	-16.680399999999999				
	<b>Latitude</b>	+29.356744				
	<b>Longitude</b>	-98.51314				
<b>SUE</b>	<b>Level of Investigation Req'd</b>	NONE				
	<b>Test Hole No</b>	N/A				
	<b>Test Hole Depth</b>	N/A				
<b>RESOLUTION</b>	<b>Recommended Action</b>	NO CONFLICT				
	<b>Estimated Resolution Date</b>					
	<b>Resolution Status</b>	NO RESOLUTION WAS REQUIRED				
	<b>Comment</b>	Pole diameter = 12" Back of curb to pole = 2'-11" Pole to back of sidewalk = 1'-2"
