## Utility Conflict Report

<b>OWNER</b>	<b>Utility</b>	SAWS	<b>Corridor</b>	SW MILITARY	<b>SITE PHOTOS</b>	
	<b>Contact</b>	ANN PECHE	<b>ID</b>	7130		
<b>GENERAL INFO</b>	<b>Utility</b>	SANITARY SEWER

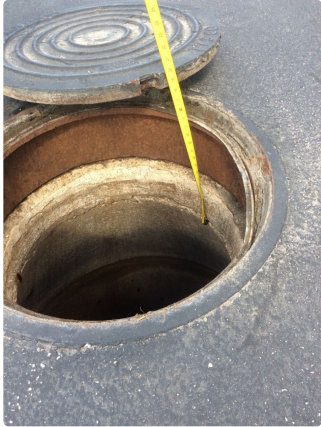
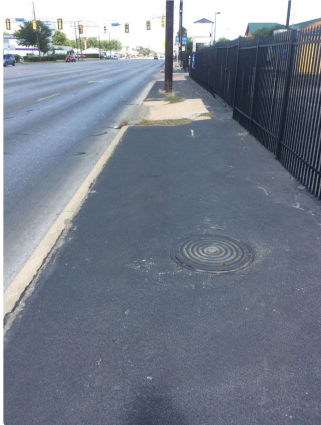
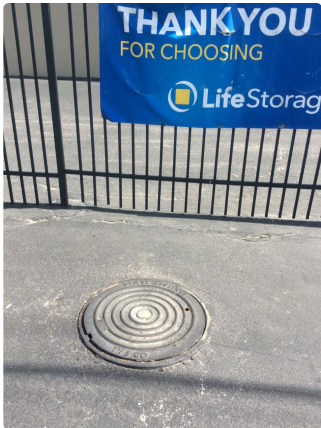
<b>Size and Material</b>	STANDARD MANHOLE, CAST IRON				
	<b>Accessible Route</b>	ASSET IS INSIDE ACCESSIBLE ROUTE				
	<b>Longitudinal or Crossing</b>	CROSSING				
	<b>Placement Relative to ROW</b>	INSIDE ROW				
<b>LOCATION</b>	<b>Sheet No.</b>	184

<b>Test Hole No</b>	N/A				
	<b>Test Hole Depth</b>	N/A				
<b>RESOLUTION</b>	<b>Recommended Action</b>	MINIMIZE - PROTECT IN PLACE				
	<b>Estimated Resolution Date</b>					
	<b>Resolution Status</b>	UTILITY OWNER INFORMED OF UTILITY				
	<b>Comment</b>	Top of cone to surface = 14" Manhole to fence = 3'-1" Back of curb to manhole = 3'-6"
