## Utility Conflict Report

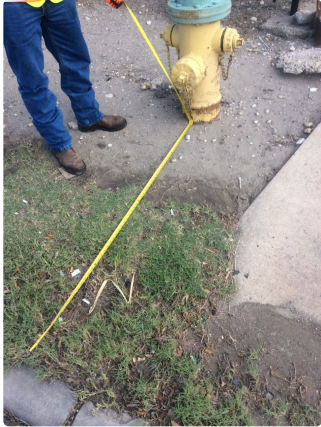
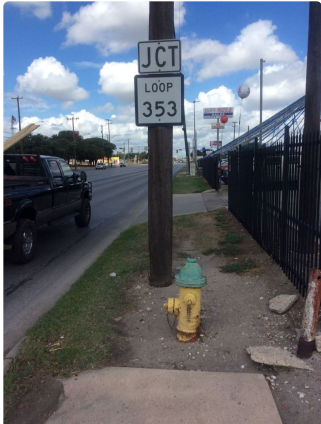
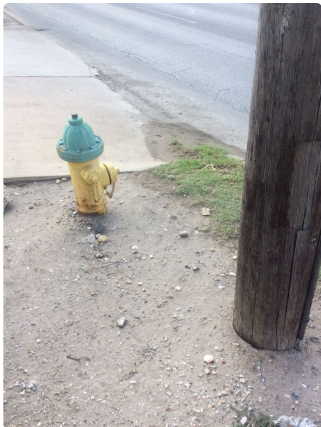
<b>OWNER</b>	<b>Utility</b>	SAWS	<b>Corridor</b>	SW MILITARY	<b>SITE PHOTOS</b>
	<b>Contact</b>	ANN PECHE	<b>ID</b>	7136	
<b>GENERAL INFO</b>	<b>Utility</b>	WATER			
	<b>Size and Material</b>	STANDARD FIRE HYDRANT			
	<b>Accessible Route</b>	ASSET IS INSIDE ACCESSIBLE ROUTE			
	<b>Longitudinal or Crossing</b>	CROSSING			
	<b>Placement Relative to ROW</b>	INSIDE ROW			
<b>LOCATION</b>	<b>Sheet No.</b>	179			
	<b>Station</b>	768+00.38			
	<b>Offset</b>	-18.6414			
	<b>Latitude</b>	+29.358237			
	<b>Longitude</b>	-98.55774			
<b>SUE</b>	<b>Level of Investigation Req'd</b>	NONE			
	<b>Test Hole No</b>	N/A			
	<b>Test Hole Depth</b>	N/A			
<b>RESOLUTION</b>	<b>Recommended Action</b>	NO CONFLICT			
	<b>Estimated Resolution Date</b>				
	<b>Resolution Status</b>	NO RESOLUTION WAS REQUIRED			
	<b>Comment</b>	Back of curb to hydrant = 4'-11" Fence to hydrant = 3'-9" Pole to hydrant = 4'-3"			
<b>Date Collected</b>		8/6/2018 11:27:45 AM		<b>Date Modified</b> 11/28/2018 6:59:12 AM
