## Utility Conflict Report

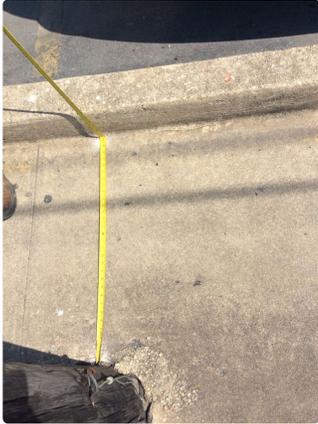
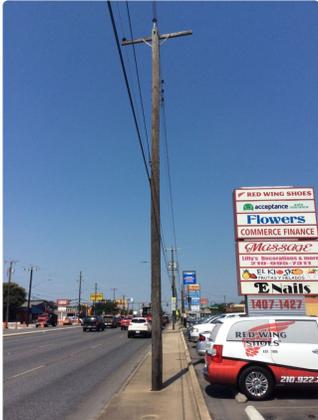
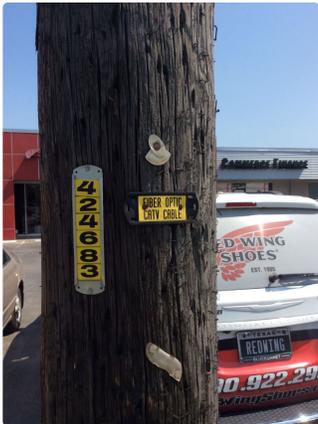
<b>OWNER</b>	<b>Utility</b>	CPS	<b>Corridor</b>	SW MILITARY	<b>SITE PHOTOS</b>	
	<b>Contact</b>	JAKE MARTINEZ	<b>ID</b>	7066		
<b>GENERAL INFO</b>	<b>Utility</b>	ELECTRIC				
	<b>Size and Material</b>	STANDARD POWER POLE, TIMBER				
	<b>Accessible Route</b>	ASSET IS INSIDE ACCESSIBLE ROUTE				
	<b>Longitudinal or Crossing</b>	CROSSING				
	<b>Placement Relative to ROW</b>	INSIDE ROW				
<b>LOCATION</b>	<b>Sheet No.</b>	200				
	<b>Station</b>	904+74.28				
	<b>Offset</b>	-16.34				
	<b>Latitude</b>	+29.356851				
	<b>Longitude</b>	-98.51502				
<b>SUE</b>	<b>Level of Investigation Req'd</b>	NONE				
	<b>Test Hole No</b>	N/A				
	<b>Test Hole Depth</b>	N/A				
<b>RESOLUTION</b>	<b>Recommended Action</b>	ACCOMODATE - RELOCATION				
	<b>Estimated Resolution Date</b>					
	<b>Resolution Status</b>	UTILITY OWNER INFORMED OF UTILITY				
	<b>Comment</b>	Pole ID: 424683 Back of curb to pole = 2'-5" Pole to back of sidewalk = 2'-6" Pole diameter = 10" CATV cable Relocate pole to ROW with electric lines cantilevered toward the roadway
