## Utility Conflict Report

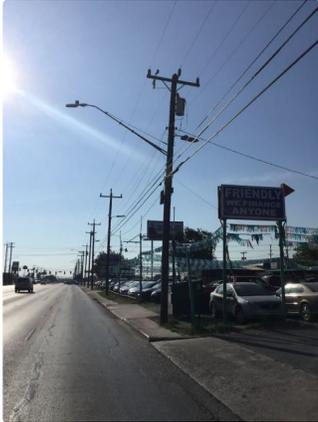
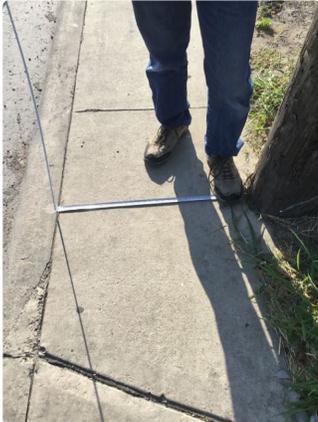
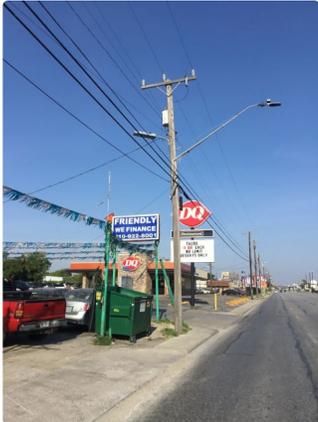
<b>OWNER</b>	<b>Utility</b>	CPS	<b>Corridor</b>	SW MILITARY	<b>SITE PHOTOS</b>		
	<b>Contact</b>	JAKE MARTINEZ	<b>ID</b>	4117			
<b>GENERAL INFO</b>	<b>Utility</b>	ELECTRIC					
	<b>Size and Material</b>	STANDARD POWER POLE, TIMBER					
	<b>Accessible Route</b>	ASSET IS INSIDE ACCESSIBLE ROUTE					
	<b>Longitudinal or Crossing</b>	CROSSING					
	<b>Placement Relative to ROW</b>	INSIDE ROW					
<b>LOCATION</b>	<b>Sheet No.</b>	135					
	<b>Station</b>	560+08.88					
	<b>Offset</b>	15.35					
	<b>Latitude</b>	+29.357457					
	<b>Longitude</b>	-98.55101					
<b>SUE</b>	<b>Level of Investigation Req'd</b>	NONE					
	<b>Test Hole No</b>	N/A					
	<b>Test Hole Depth</b>	N/A					
<b>RESOLUTION</b>	<b>Recommended Action</b>	ACCOMODATE - RELOCATION					
	<b>Estimated Resolution Date</b>						
	<b>Resolution Status</b>	UTILITY OWNER INFORMED OF UTILITY					
	<b>Comment</b>	Pole ID: LA1785411; LW41744; 452729 Pole to back of curb = 2'-6 1/2" Sidewalk width = 2'-11" CATV cable Relocate pole to ROW with electric lines cantilevered toward the roadway
