## Utility Conflict Report

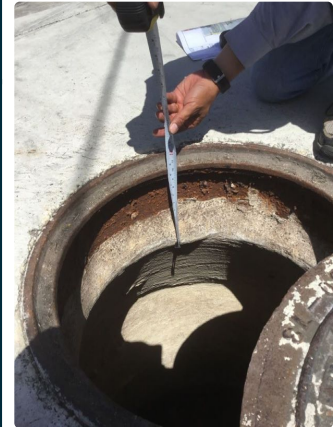
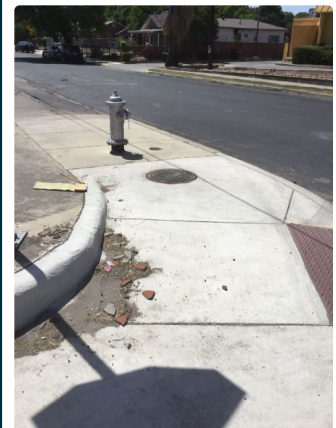
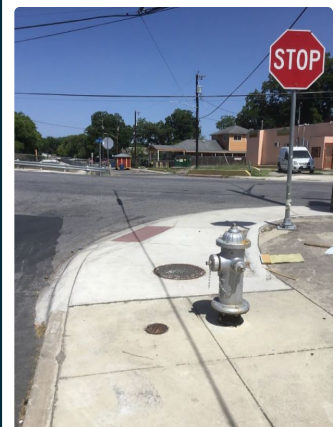
<b>OWNER</b>	<b>Utility</b>	SAWS	<b>Corridor</b>	NOGALITOS	<b>SITE PHOTOS</b>		
	<b>Contact</b>	NINA BITTLE	<b>ID</b>	3023			
<b>GENERAL INFO</b>	<b>Utility</b>	SANITARY SEWER					
	<b>Size and Material</b>	STANDARD MANHOLE, CAST IRON					
	<b>Accessible Route</b>	ASSET IS INSIDE ACCESSIBLE ROUTE					
	<b>Longitudinal or Crossing</b>	CROSSING					
	<b>Placement Relative to ROW</b>	INSIDE ROW					
<b>LOCATION</b>	<b>Sheet No.</b>						
	<b>Station</b>	114+75.48					
	<b>Offset</b>	-41.6481					
	<b>Latitude</b>	+29.389397					
	<b>Longitude</b>	-98.52146					
<b>SUE</b>	<b>Level of Investigation Req'd</b>	NONE					
	<b>Test Hole No</b>	N/A					
	<b>Test Hole Depth</b>	N/A					
<b>RESOLUTION</b>	<b>Recommended Action</b>	NO CONFLICT					
	<b>Estimated Resolution Date</b>	8/13/2018					
	<b>Resolution Status</b>	NO RESOLUTION WAS REQUIRED					
	<b>Comment</b>	Bottom of cone to surface = 11" Lid flange thickness = 1" Sidewalk width = 7'-4"
