Utility Conflict Report

OWNER	Utility	CPS	Corridor	NOGALITOS	SITE PHOTOS		
	Contact	JAKE MARTINEZ	ID	3034			
GENERAL INFO	Utility	ELECTRIC

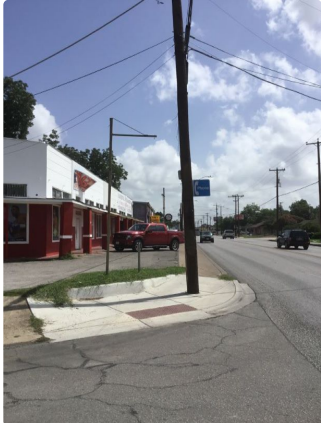
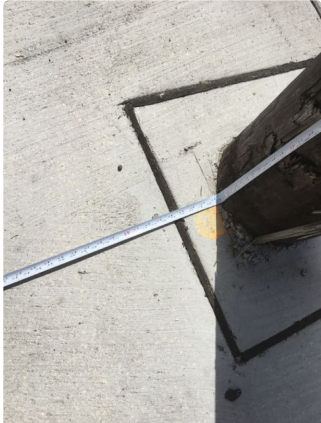
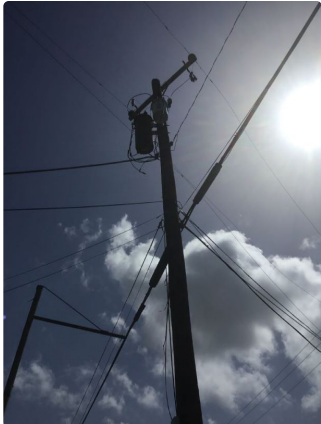
Size and Material	STANDARD POWER POLE, TIMBER					
	Accessible Route	ASSET IS INSIDE ACCESSIBLE ROUTE					
	Longitudinal or Crossing	CROSSING					
	Placement Relative to ROW	INSIDE ROW					
LOCATION	Sheet No.	82

Test Hole No	N/A					
	Test Hole Depth	N/A					
RESOLUTION	Recommended Action	MINIMIZE - PROTECT IN PLACE					
	Estimated Resolution Date						
	Resolution Status	UTILITY OWNER INFORMED OF UTILITY					
	Comment	Pole marking: 2119 Pole to face of wall = 3'-10" Pole to back of curb = 3'-0"					
Date Collected		7/10/2018 10:59:52 AM		Date Modified		9/13/2018 2:01:20 PM
