Utility Conflict Report

OWNER	Utility	SAWS	Corridor	NOGALITOS	SITE PHOTOS		
	Contact	NINA BITTLE	ID	4019			
GENERAL INFO	Utility	WATER

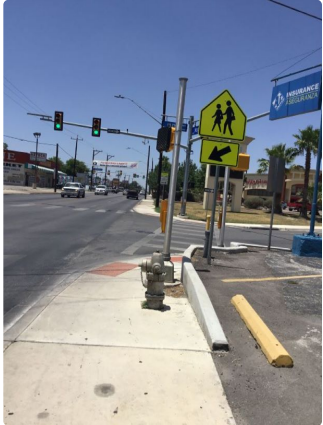
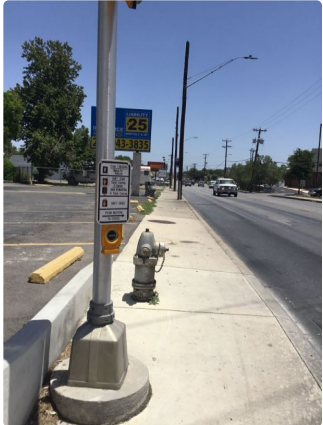
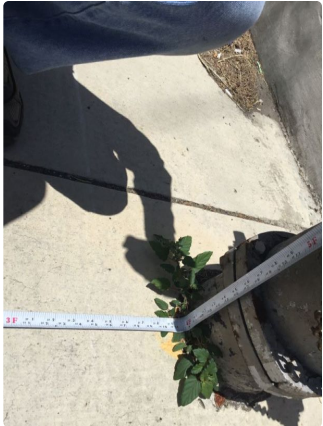
Size and Material	STANDARD FIRE HYDRANT					
	Accessible Route	ASSET IS INSIDE ACCESSIBLE ROUTE					
	Longitudinal or Crossing	CROSSING					
	Placement Relative to ROW	INSIDE ROW					
LOCATION	Sheet No.

Test Hole No	N/A					
	Test Hole Depth	N/A					
RESOLUTION	Recommended Action	NO CONFLICT					
	Estimated Resolution Date	8/13/2018					
	Resolution Status	NO RESOLUTION WAS REQUIRED					
	Comment	Back of curb to hydrant = 4'-0"					
Date Collected		7/2/2018 12:49:15 PM		Date Modified		8/14/2018 4:38:26 PM
