## Utility Conflict Report

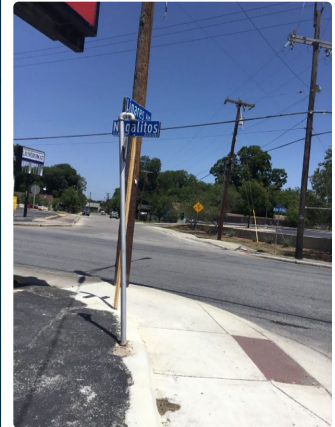
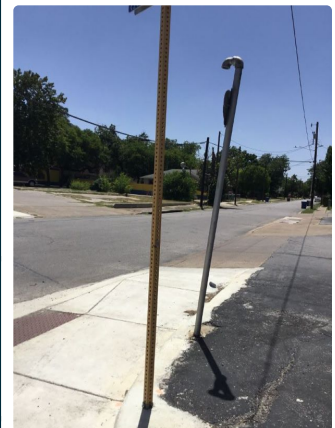
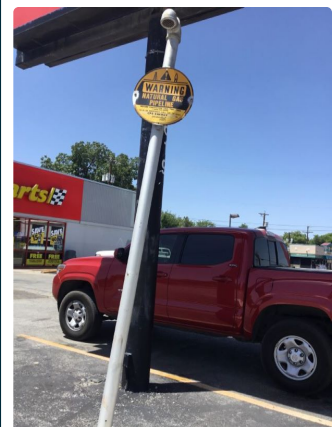
<b>OWNER</b>	<b>Utility</b>	CPS	<b>Corridor</b>	NOGALITOS	<b>SITE PHOTOS</b>
	<b>Contact</b>	JAKE MARTINEZ	<b>ID</b>	4030	
<b>GENERAL INFO</b>	<b>Utility</b>	GAS			
	<b>Size and Material</b>	UNKNOWN			
	<b>Accessible Route</b>	ASSET IS OUTSIDE ACCESSIBLE ROUTE			
	<b>Longitudinal or Crossing</b>	CROSSING			
	<b>Placement Relative to ROW</b>	INSIDE ROW			
<b>LOCATION</b>	<b>Sheet No.</b>				
	<b>Station</b>	111+81.61			
	<b>Offset</b>	-33.583			
	<b>Latitude</b>	+29.388786			
	<b>Longitude</b>	-98.52206			
<b>SUE</b>	<b>Level of Investigation Req'd</b>	NONE			
	<b>Test Hole No</b>	N/A			
	<b>Test Hole Depth</b>	N/A			
<b>RESOLUTION</b>	<b>Recommended Action</b>	NO CONFLICT			
	<b>Estimated Resolution Date</b>	8/13/2018			
	<b>Resolution Status</b>	NO RESOLUTION WAS REQUIRED			
	<b>Comment</b>	Vertical gas line adjacent to back of wall			
<b>Date Collected</b>		7/2/2018 2:58:51 PM	<b>Date Modified</b>		8/14/2018 4:38:26 PM
