Utility Conflict Report

OWNER	Utility	SAWS	Corridor	NOGALITOS	SITE PHOTOS	
	Contact	ANN PECHE	ID	4037		
GENERAL INFO	Utility	SANITARY SEWER

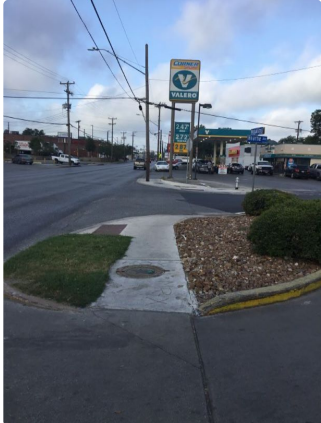
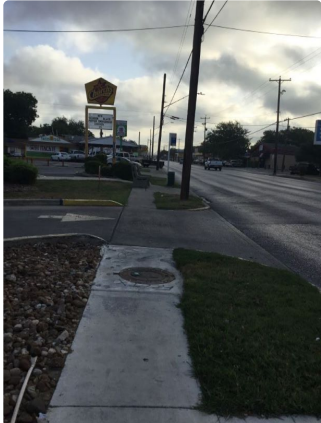
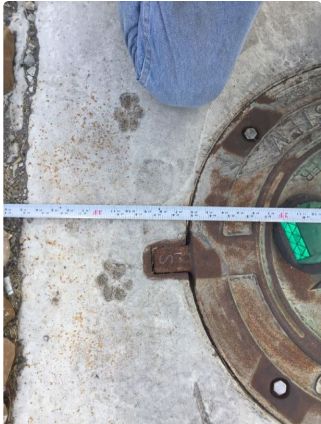
Size and Material	STANDARD MANHOLE, CAST IRON				
	Accessible Route	ASSET IS INSIDE ACCESSIBLE ROUTE				
	Longitudinal or Crossing	CROSSING				
	Placement Relative to ROW	INSIDE ROW				
LOCATION	Sheet No.	115

Estimated Resolution Date					
	Resolution Status	UTILITY OWNER INFORMED OF UTILITY				
	Comment	Sidewalk width = 3'-5" Unable to open manhole Adjust rim flush with reconstructed sidewalk				
Date Collected		7/3/2018 7:50:37 AM		Date Modified	10/12/2018 3:14:06 PM

Test Hole No	N/A				
	Test Hole Depth	N/A				
RESOLUTION	Recommended Action	MINIMIZE - PROTECT IN PLACE
