## Utility Conflict Report

<b>OWNER</b>	<b>Utility</b>	CPS	<b>Corridor</b>	NOGALITOS	<b>SITE PHOTOS</b>		
	<b>Contact</b>	JAKE MARTINEZ	<b>ID</b>	4070			
<b>GENERAL INFO</b>	<b>Utility</b>	ELECTRIC

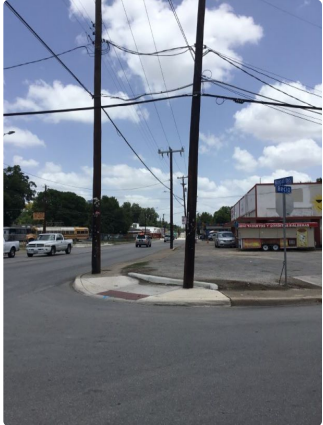
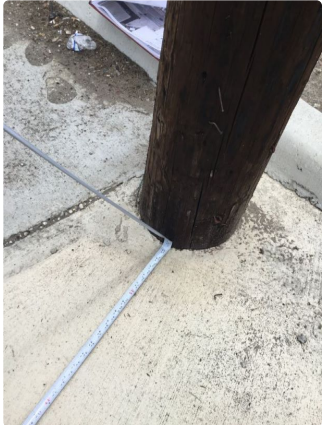
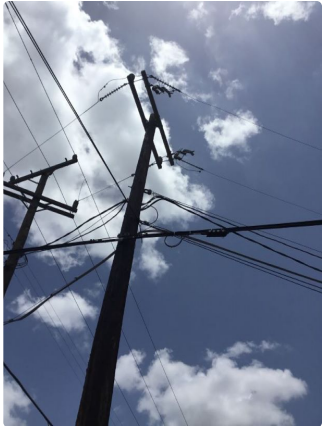
<b>Size and Material</b>	STANDARD POWER POLE, TIMBER					
	<b>Accessible Route</b>	ASSET IS INSIDE ACCESSIBLE ROUTE					
	<b>Longitudinal or Crossing</b>	CROSSING					
	<b>Placement Relative to ROW</b>	INSIDE ROW					
<b>LOCATION</b>	<b>Sheet No.</b>

<b>Test Hole No</b>	N/A					
	<b>Test Hole Depth</b>	N/A					
<b>RESOLUTION</b>	<b>Recommended Action</b>	NO CONFLICT					
	<b>Estimated Resolution Date</b>	8/13/2018					
	<b>Resolution Status</b>	NO RESOLUTION WAS REQUIRED					
	<b>Comment</b>	Pole marking: R14012 Pole to back of curb = 5'-7"
