## Utility Conflict Report

<b>OWNER</b>	<b>Utility</b>	CPS	<b>Corridor</b>	NOGALITOS	<b>SITE PHOTOS</b>		
	<b>Contact</b>	JAKE MARTINEZ	<b>ID</b>	4080			
<b>GENERAL INFO</b>	<b>Utility</b>	ELECTRIC

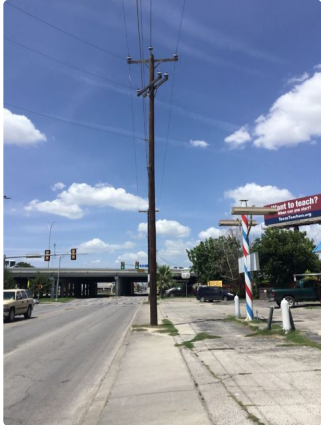
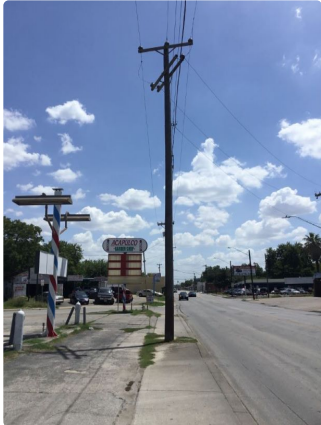
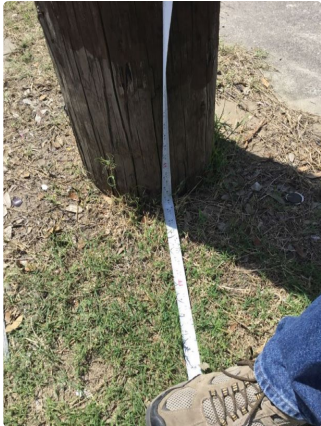
<b>Size and Material</b>	STANDARD POWER POLE, TIMBER					
	<b>Accessible Route</b>	ASSET IS INSIDE ACCESSIBLE ROUTE					
	<b>Longitudinal or Crossing</b>	CROSSING					
	<b>Placement Relative to ROW</b>	INSIDE ROW

<b>Test Hole No</b>	N/A					
	<b>Test Hole Depth</b>	N/A					
<b>RESOLUTION</b>	<b>Recommended Action</b>	MINIMIZE - PROTECT IN PLACE					
	<b>Estimated Resolution Date</b>						
	<b>Resolution Status</b>	UTILITY OWNER INFORMED OF UTILITY					
	<b>Comment</b>	Pole to back of sidewalk = 1'-8" Pole to back of curb = 2'-6" Sidewalk width = 5'-0" No pole ID
