## Data Collection Report

| <b>GENERAL INFO</b> | <b>LOCID</b> | 7 | <b>Latitude</b> | +26.477353 |
| | <b>Highway</b> | US 83 | <b>Longitude</b> | -99.047798 |
| | <b>CSJ</b> | 0038-06-047 | | |

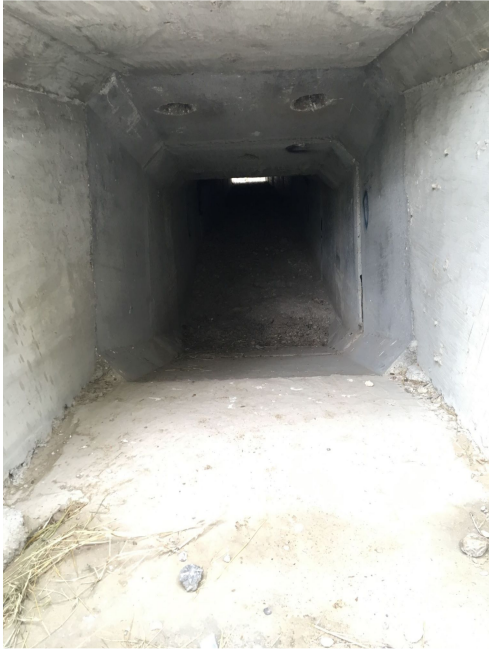
| <b>Photo 1</b> | | | | |

| | <b>Field Notes</b> | 4x4 box- major erosion under mow strip riprap<br>31" guardrail-box is very silted | | |
